Casitas Municipal Water District  
RECREATION COMMITTEE  
Special Meeting Agenda  
Brennan/Kaiser  
**September 13, 2021 – 10:00 a.m.**

**CASITAS MUNICIPAL WATER DISTRICT**  
**Committee Memo**

SUBJECT: Casitas Water Adventure Condition Assessment

Casitas Municipal Water  
District  
Casitas Water Adventure  
Facility Assessment Report  
June 24, 2021

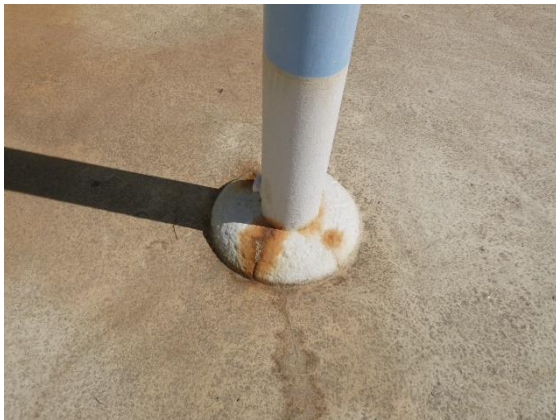
Fig 1.3. Corrosion on base supports

1. **Structure:** Upon initial review of the children's interactive play structure, the following items were observed.
  - a. The foundation supports had numerous cracks with visible rust showing on the exterior. The areas of rust, corrosion and cracking were prevalent on the majority of supports. The support framers underneath the platforms also show significant signs of corrosion and portions of the beams were flaking/chipping off when touched.

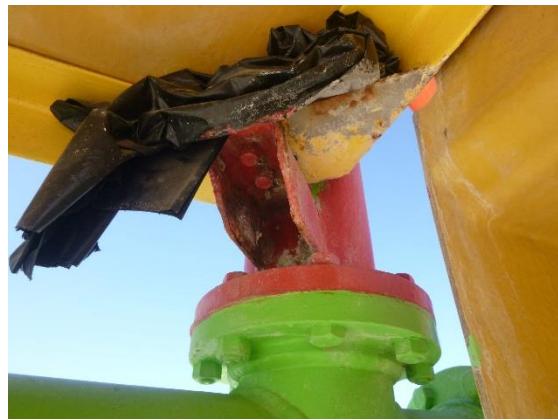
Fig 1.4. Corrosion underneath platforms

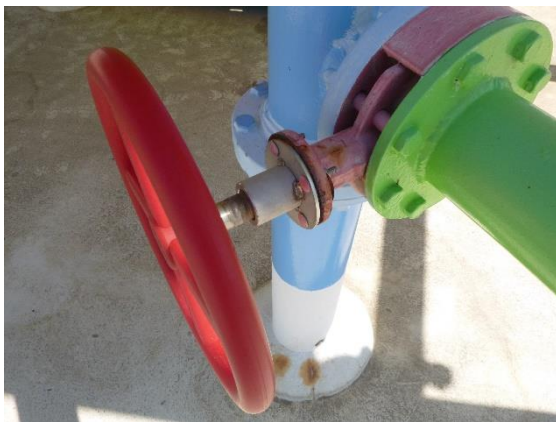
Fig 1.5. Steering wheel joint corrosion

- d. The structure has several steering wheel features that can be turned by users to spray water. The steel where the steering wheel on the northwest side of the play structure connects has corroded and there are sharp edges of rusted steel behind the wheel. Per manufacturer guidelines, interactive elements (guns, wheels, tipping buckets, etc.) should be in good condition with no loose fasteners, no rust or corrosion and contain no sharp edges.

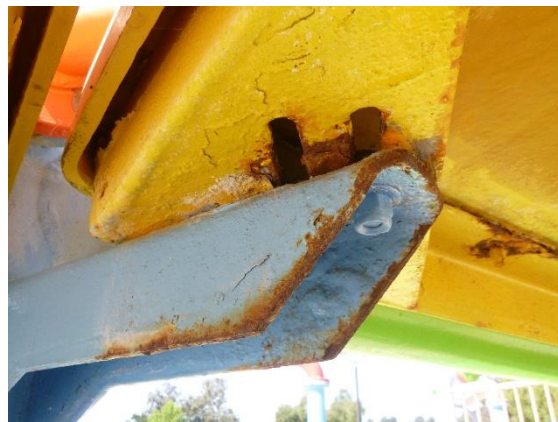
Fig 1.6. Corrosion underneath platforms

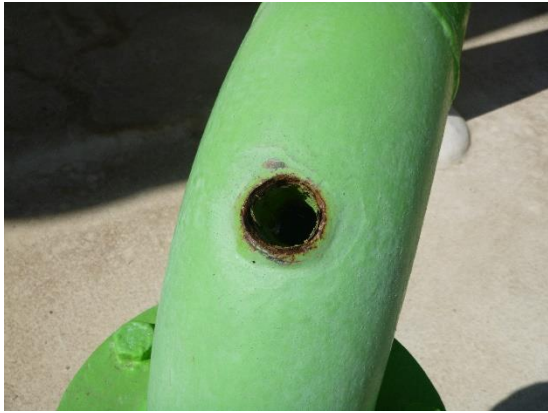
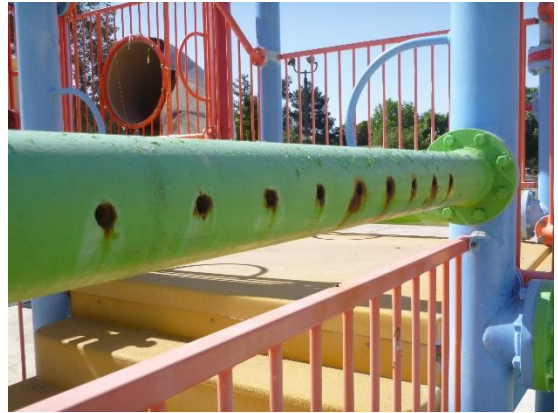
Fig. 1.7. Water feature corrosion

- e. When looking into the water spray jets from the structure's green piping (Figures 1.7/1.8) the interior corrosion of that pipe is clearly visible, and the rust has stained the exterior of the pipe.

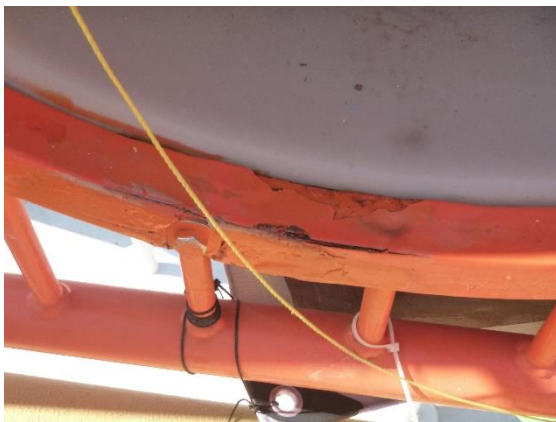
Fig 1.9. Waterslide opening corrosion

- c. The dual waterslides' base supports under the slides are cracked and rusted rails were observed at the slide opening.
  - d. Staff reported slide rules are posted during the operating season along with height requirements.

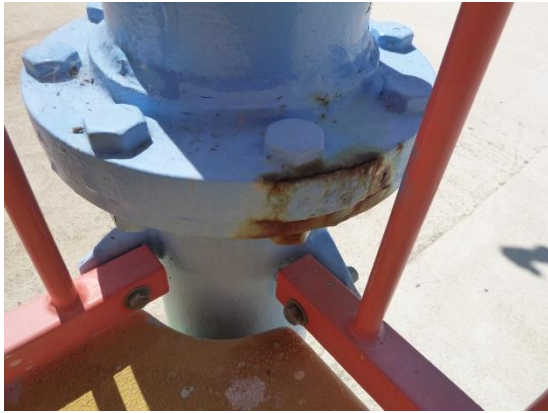
Fig. 1.13. Corrosion on structure

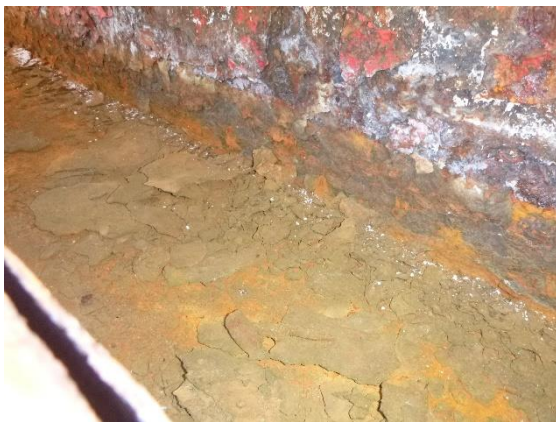
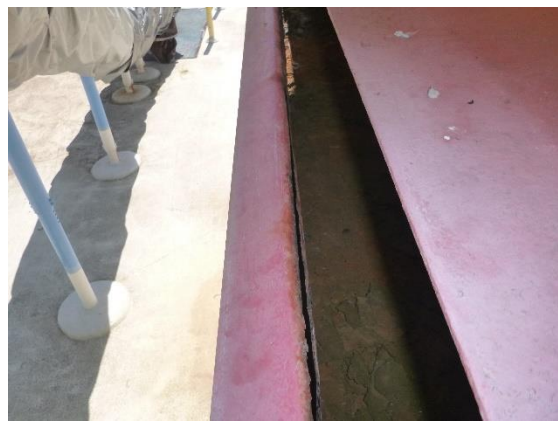
Fig 1.15. Interior water trough corrosion

- b. The one remaining water trough shows significant signs of corrosion (Figure 1.15 and 1.16) on the interior. As water fills the trough and overflows to guests below, the water could contain pieces of rusted steel.

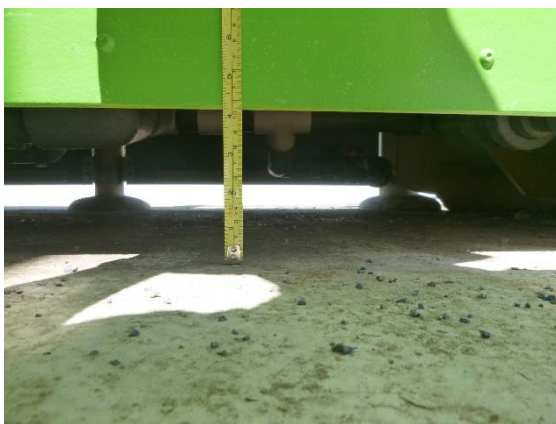
Fig 1.17. Gap at base of structure

- b. Gaps exist underneath the structure's side panels that could cause entrapment issues for users. These gaps exceed 4 inches in height.
  - c. The play structure has several areas where the low height of green support beams presents a dangerous overhang for users as their height is less than 68 inches. Low overhead elements of the structure should either be guarded to prevent access or highlighted and padded to avoid injury to users.

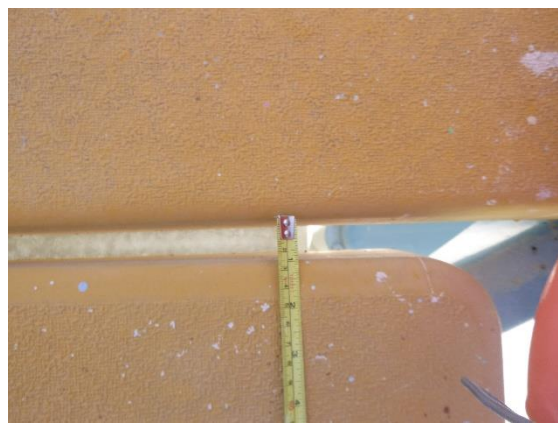
Fig 1.18 Gaps in platform connections

- b. Gaps were observed between the platform sections. This can be caused by general movement of the structure, shrinkage, or thermal expansion. Sikaflex is a one part, chlorine resistant, flexible, and elastic silicone sealant for use around swimming pools and wet areas that can be used to fill the gaps.

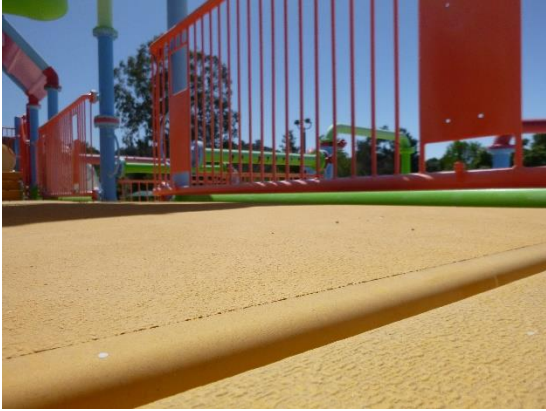
Fig. 1.19. Uneven platform connection

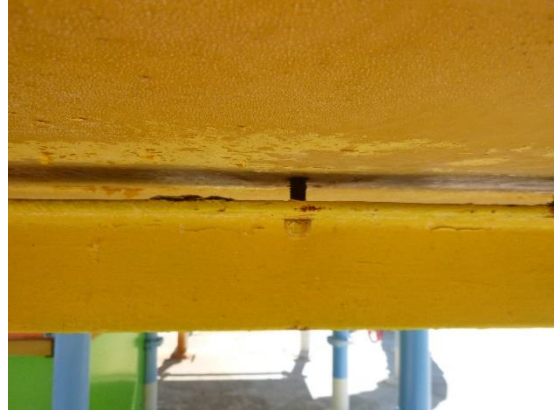
Fig 1.20. Raised platform on base support

3. **Platforms/Steps:** The existing platforms and steps are original to the play structure.
- a. The main platforms no longer rest flush on the steel supports underneath them. There appears to be loose bolts that could be causing this, though the bolt and nut are rusted (Fig 1.20). Staff should tighten bolt and observe if that help the platform to sit flush on the support beam.

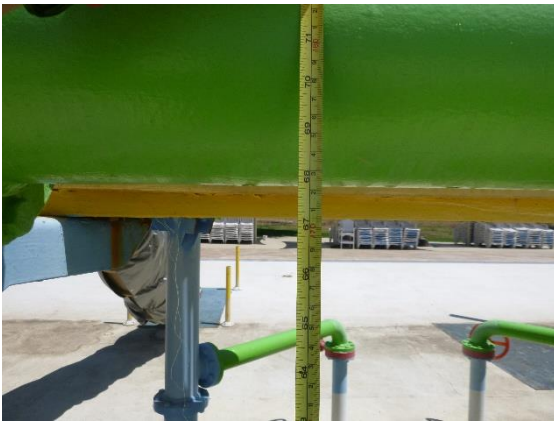
Fig 1.21. Overhang height of 68 inches

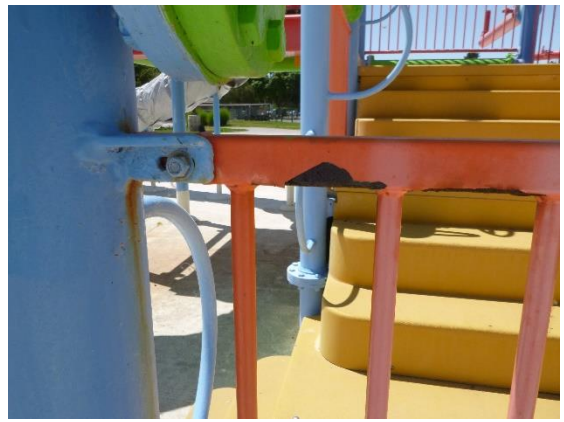
Fig 1.22. Railing corrosion

5. **Railing/Features:** Staff report that all the railings were replaced, and powder coated in 2017. Despite that, several of the structure's railings are rusting and subsequently have sharp edges. Manufacturers recommend that handrails should be in good condition, properly secured and with no sharp edges or catch points.

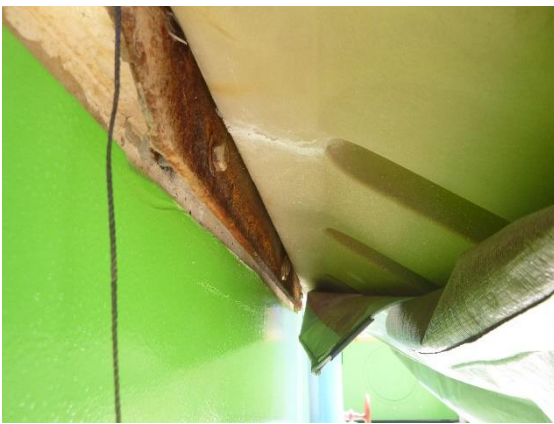
Fig 1.23. Corrosion on slide support

2. **Waterslides:** There are four waterslides on the play structure which operate without water running through them.
  - a. The mounting plate show signs of corrosion (Fig 1.23) and staff report the baby slide has been replaced five times due to cracking, mounting plate rusting out and footings needing to be replaced.

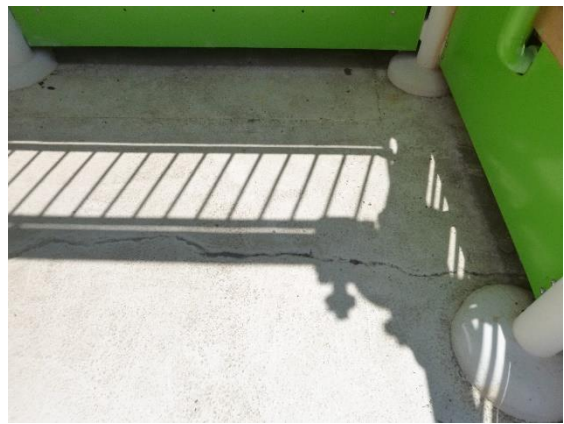
Fig 1.24. Crack in pool floor

4. **Pool Surface:** The pool surface for the play structure has numerous cracks (Figure 1.24). This is most commonly due to shifting of the pool and surrounding deck. The perimeter deck has areas where it has sunk below the pool floor and could cause a trip hazard for users.

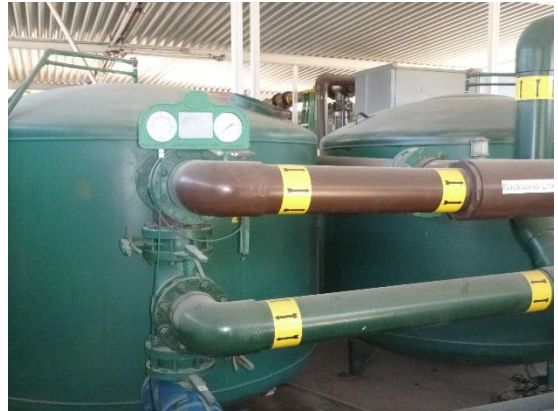
Fig 1.26. Play structure filtration

6. **Mechanical System:** Some components of the play structures' mechanical system are original to the facility, built in 1998.
- a. Staff report pumps and strainers have been replaced, but the Miami tank filters have not been replaced. The interior lining of the filters was observed to be rusting. While the filters are sized appropriately for the 684 GPM flow rate, Councilman-Hunsaker typically assigns a lifespan of 15-20 years to pool filters and would recommend that the Water District start planning for a filter replacement.

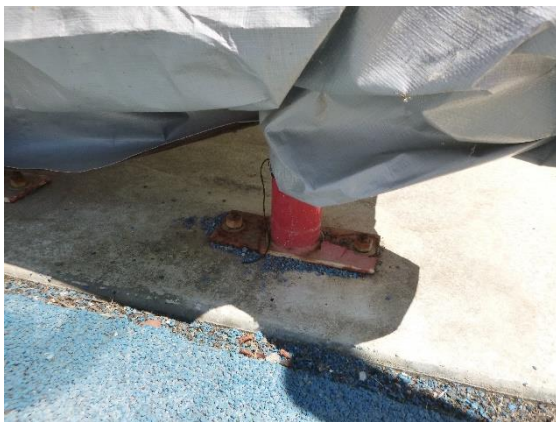
Fig 1.39. Corrosion on base slide support

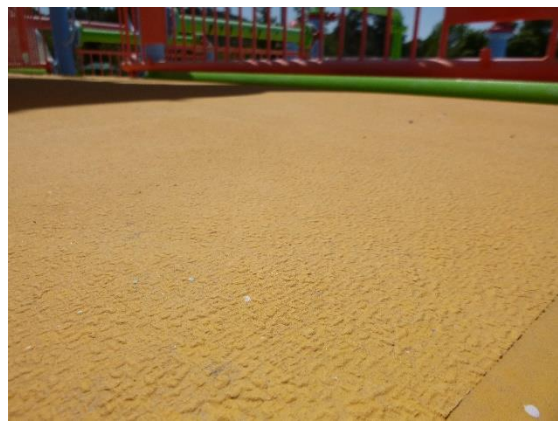
Fig 1.40. Platform surface tread

- f. One of the key areas of play structure safety is to ensure the platforms maintain their slip-resistant tread. These surfaces should be free of obstructions, cracks, chips and damage and have a non-skid surface. As platforms age their slip-resistant surface can wear down and be compromised.

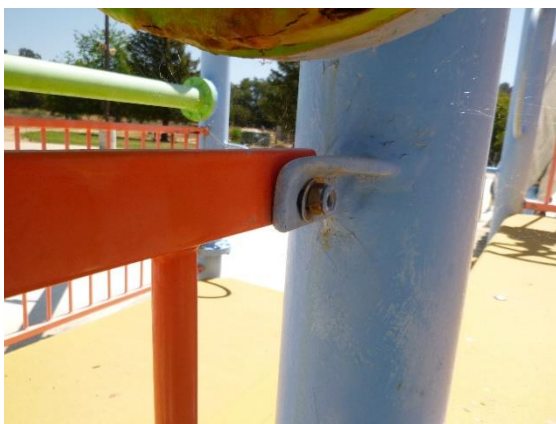
Fig 1.41. Corrosion on railing bolt connection
