Board Meeting Agenda

CASITAS MUNICIPAL WATER DISTRICT June 13, 2012 3:00 P.M. – DISTRICT OFFICE

2011 Robles Fish Passage Facility Progress Report

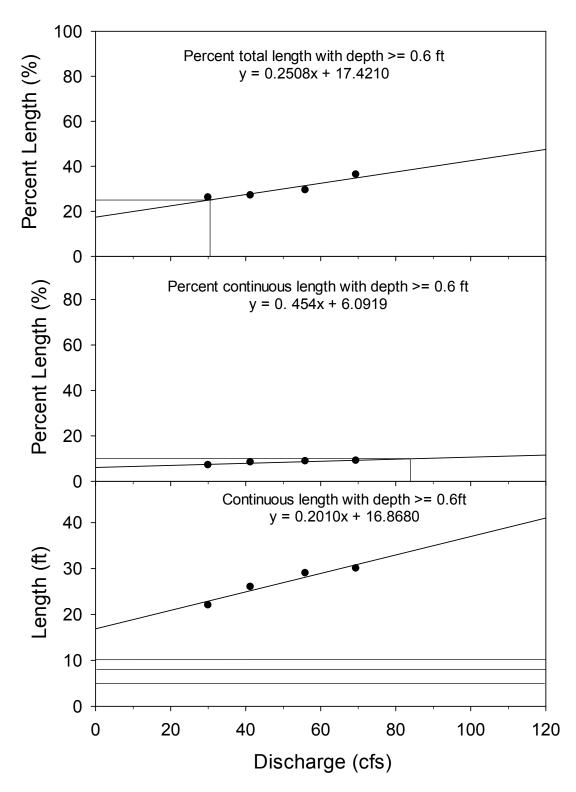
Appendix 3. Relation between Robles discharge and water depth at Site 3-2 near Casitas Springs and resulting discharge for various passage criteria.

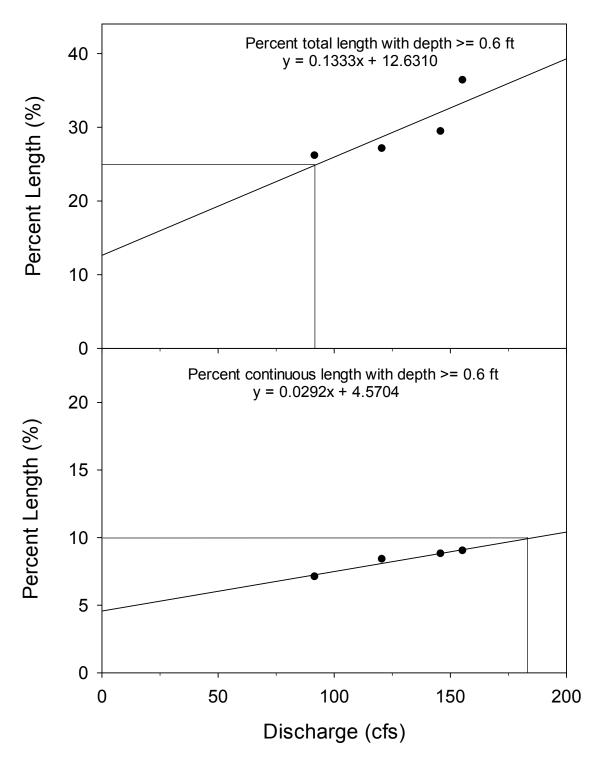
Appendix 4. Relation between site discharge and water depth at Site 3-2 near Casitas Springs and resulting discharge for the Thompson passage criteria.

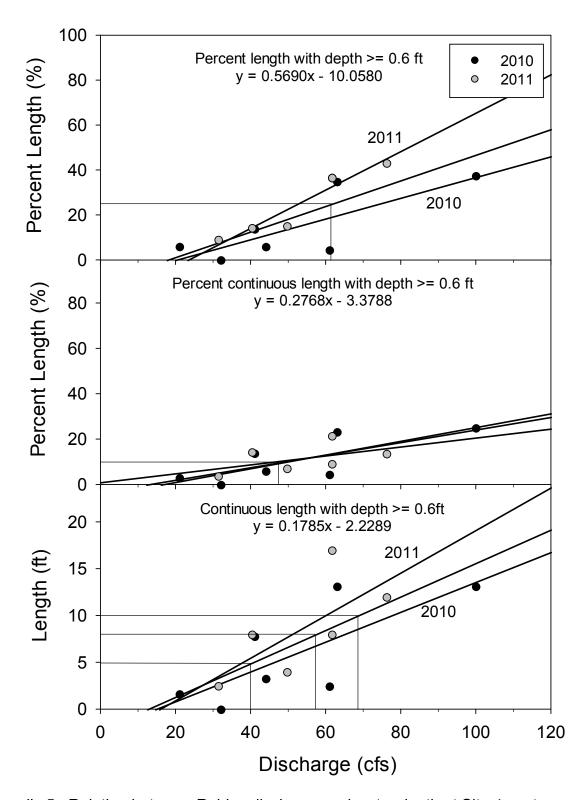
Appendix 5. Relation between Robles discharge and water depth at Site 4 upstream of San Antonio Creek and resulting discharge for various passage criteria.

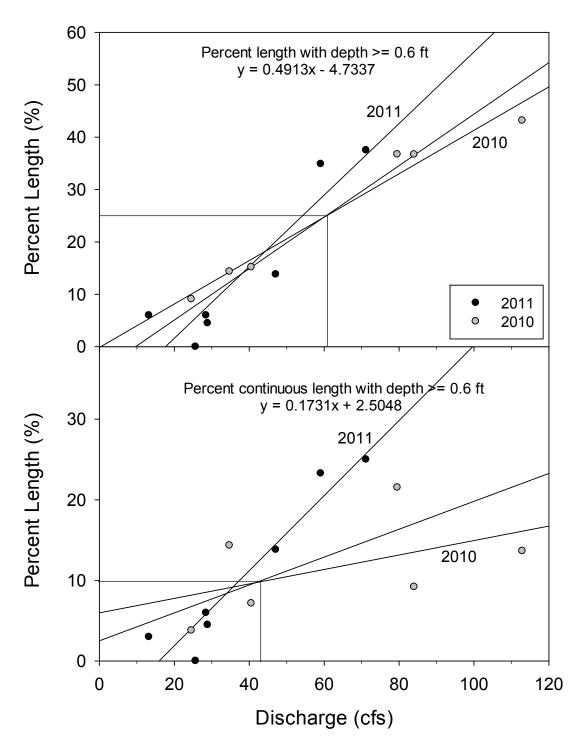
Appendix 6. Relation between site discharge and water depth at Site 4 upstream of San Antonio Creek and resulting discharge for the Thompson passage criteria.

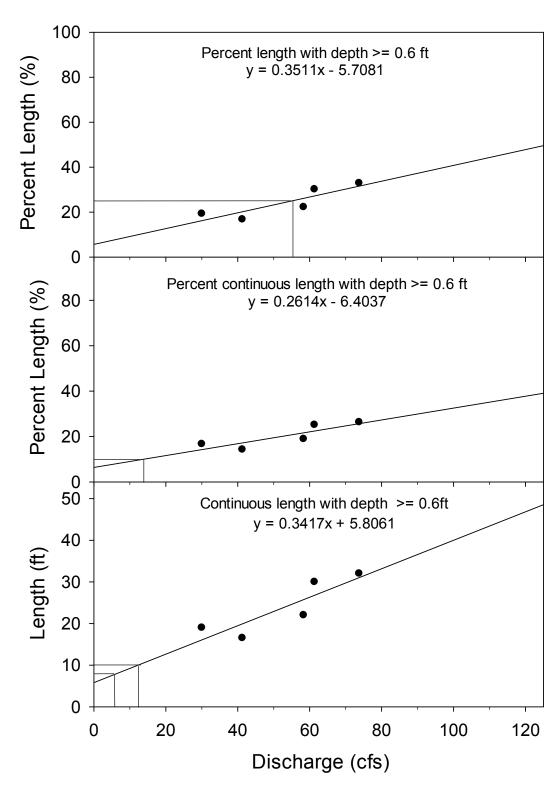
Appendix 7. Relation between Robles discharge and water depth at Site 5-2 downstream of Santa Ana bridge and resulting discharge for various passage criteria.

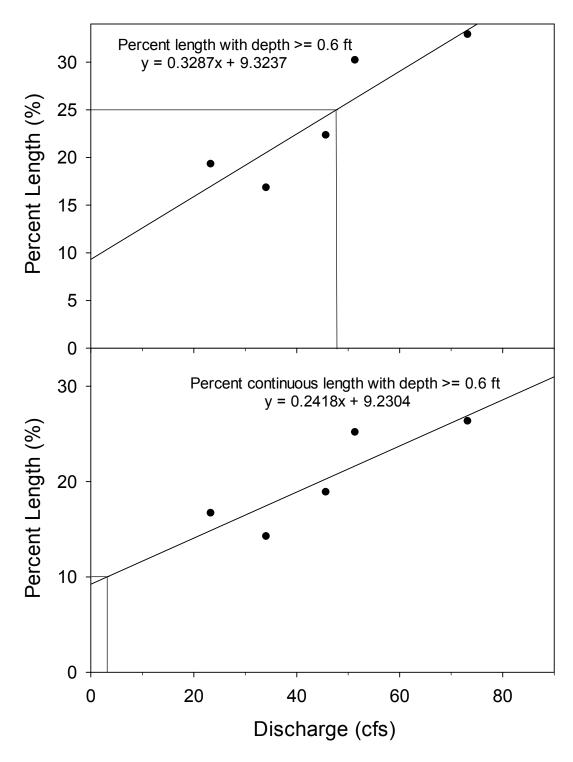
Appendix 8. Relation between site discharge and water depth at Site 5-2 downstream of Santa Ana bridge and resulting discharge for Thompson passage criteria.

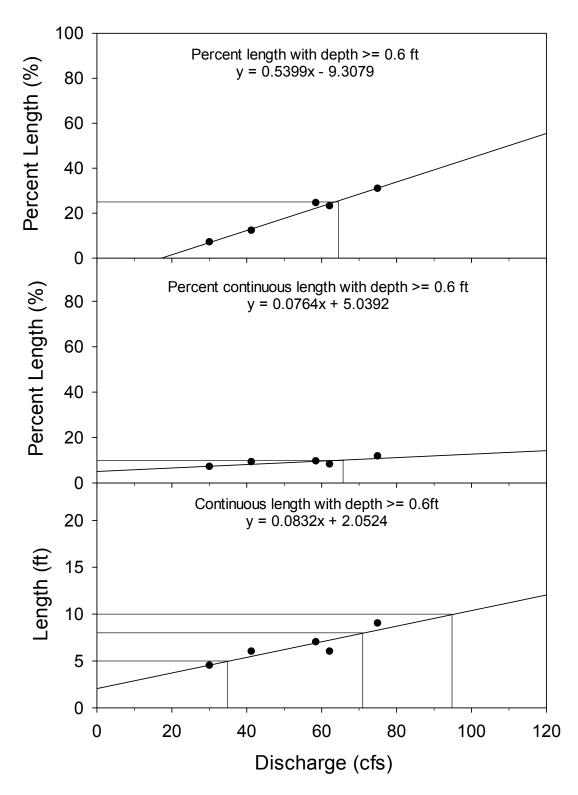
Appendix 9. Relation between Robles discharge and water depth at Site 6-2 upstream of Santa Ana bridge and resulting discharge for various passage criteria.

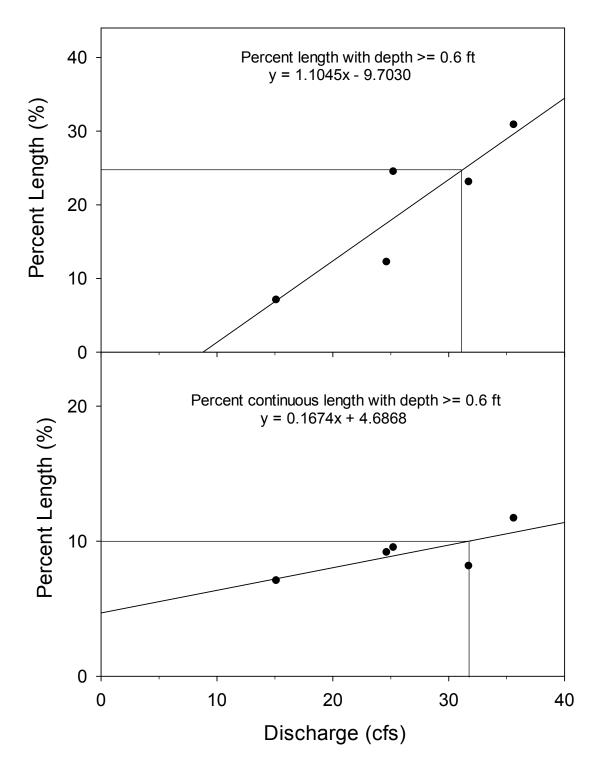
Appendix 10. Relation between site discharge and water depth at Site 6-2 upstream of Santa Ana bridge and resulting discharge for Thompson passage criteria.

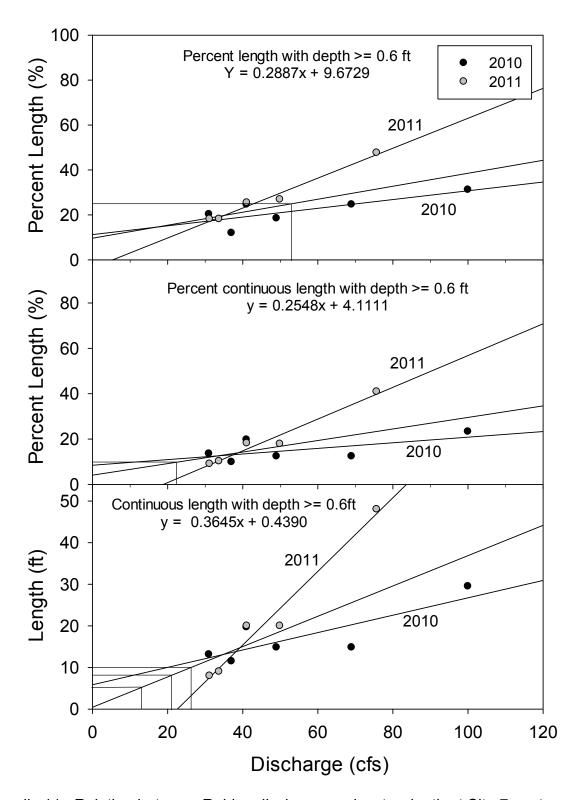
Appendix 11. Relation between Robles discharge and water depth at Site 7 upstream of Hwy 150 bridge and resulting discharge for various passage criteria.

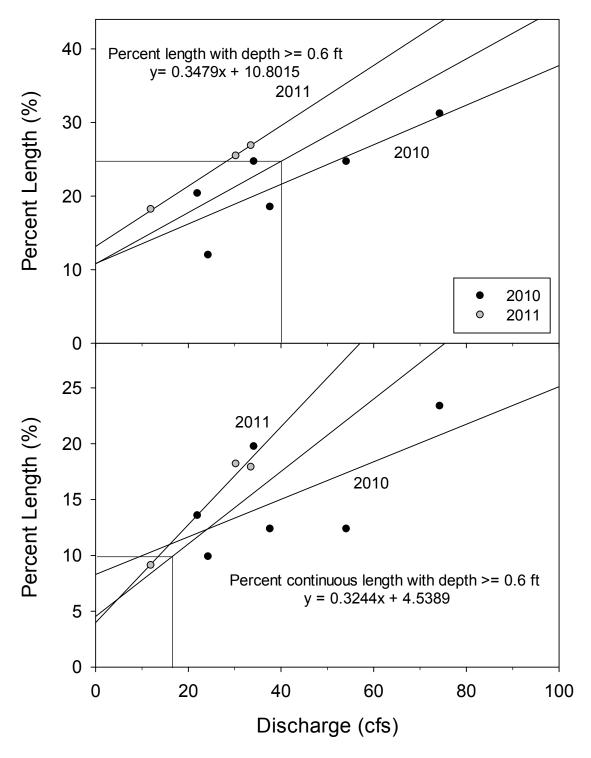
Appendix 12. Relation between site discharge and water depth at Site 7 upstream of Hwy 150 bridge and resulting discharge for Thompson passage criteria.

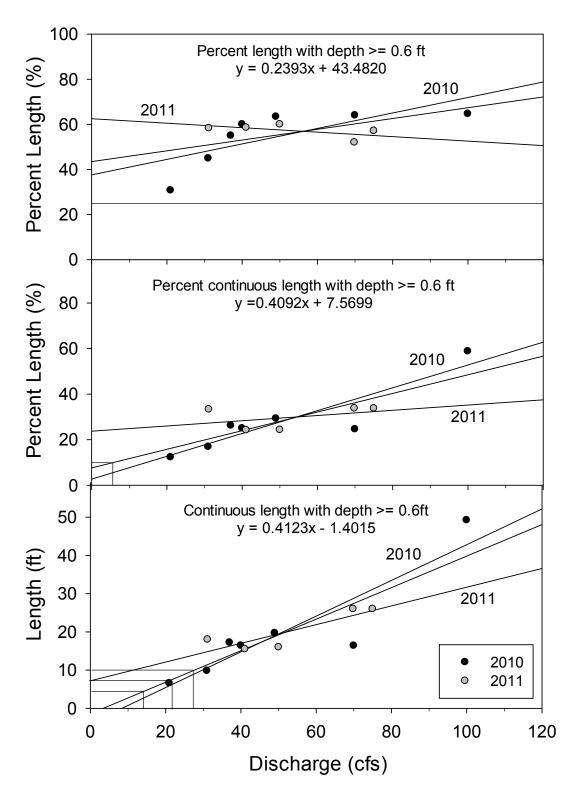
Appendix 13. Relation between Robles discharge and water depth at Site 8 downstream of the Robles Fish Facility and resulting discharge for various passage criteria.

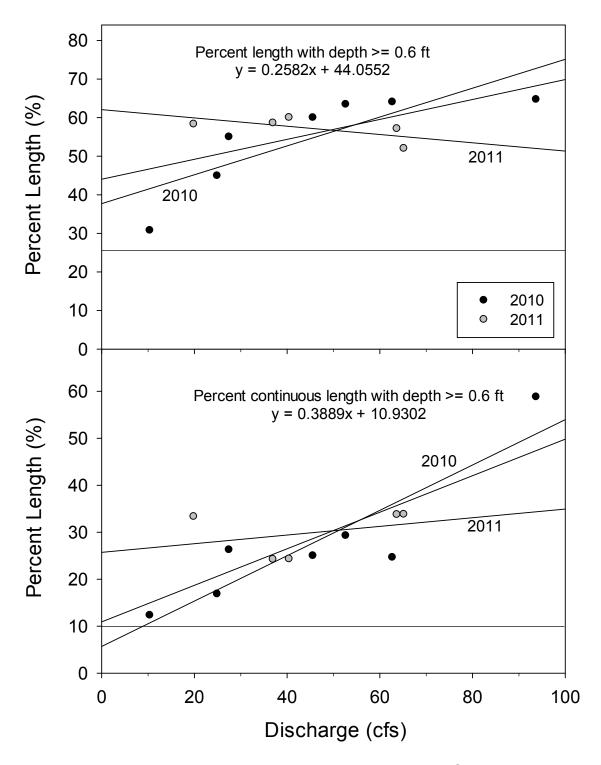
Appendix 14. Relation between site discharge and water depth at Site 8 downstream of Robles Fish Facility and resulting discharge for Thompson passage criteria.

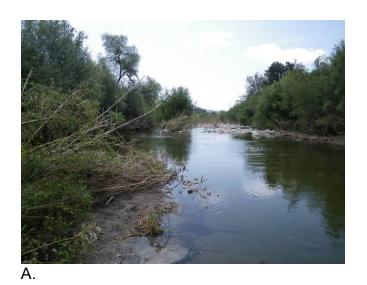
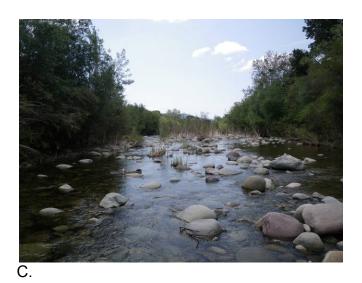
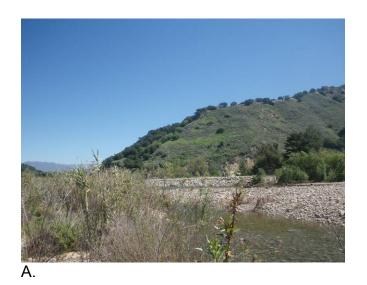
Appendix 15a. Photos of Site 2 impediment on 13 April 2011 during 64 cfs, as measured at Foster Park USGS gage, looking from: (A) upstream, (B) upstream from upstream edge of impediment, and (C) downstream from upstream edge of impediment.

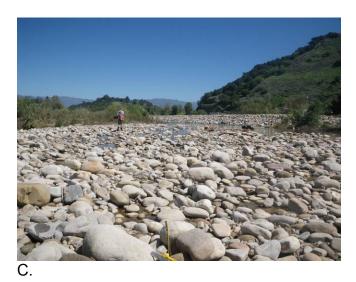
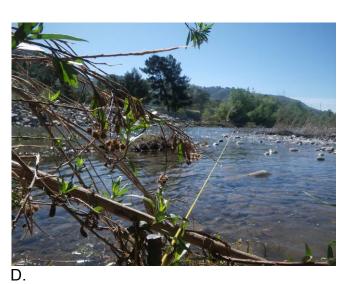
Appendix 15b. Photos of Site 3-2 impediment on 05 April 2011 during 30 cfs discharge release from Robles Fish Facility, looking from: (A) downstream, (B) upstream, (C) right to left bank, and (D) left to right bank.

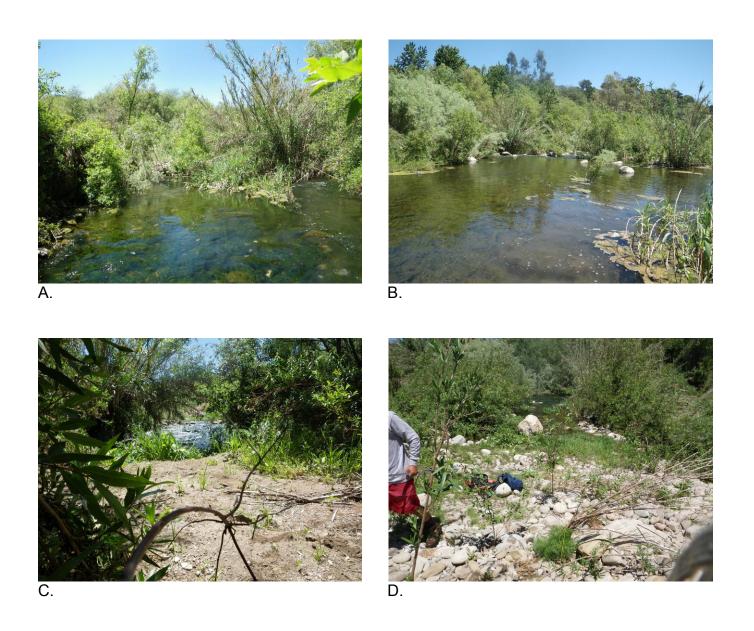
Appendix 15c. Photos of Site 4 impediment on 26 April 2011 during 31 cfs discharge release from Robles Fish Facility, looking from: (A) downstream, (B) upstream, (C) right to left bank, and (D) left to right bank.

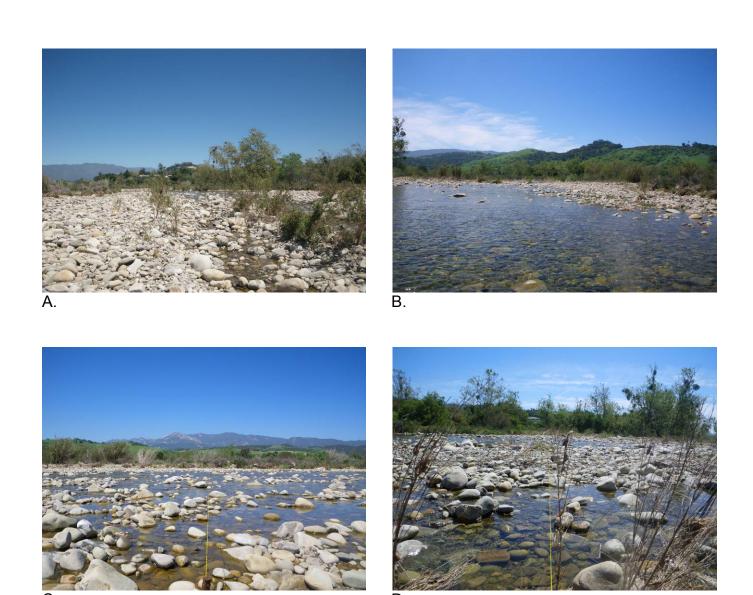
Appendix 15d. Photos of Site 5-2 impediment on 05 April 2011 during 30 cfs discharge release from Robles Fish Facility, looking from: (A) downstream, (B) upstream, (C) right to left bank, and (D) left to right bank.

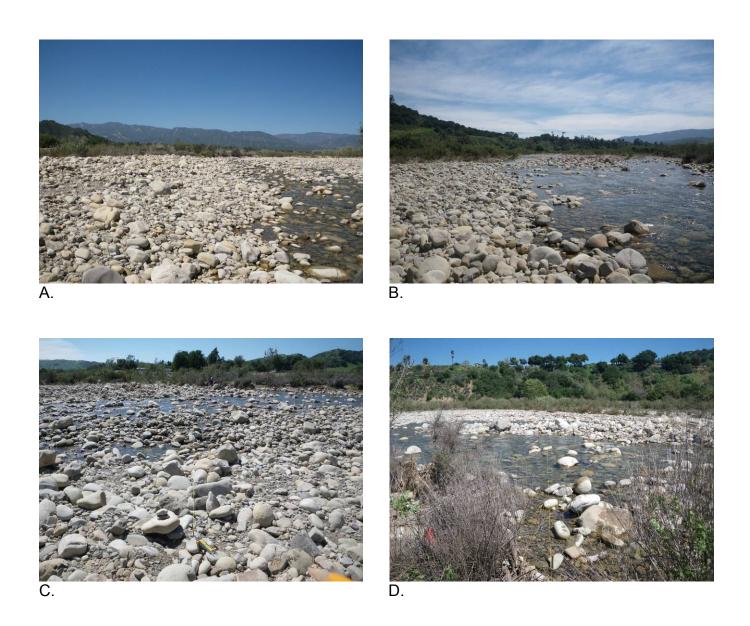
Appendix 15e. Photos of Site 6-2 impediment on 05 April 2011 during 30 cfs discharge release from Robles Fish Facility, looking from: (A) downstream, (B) upstream, (C) right to left bank, and (D) left to right bank.

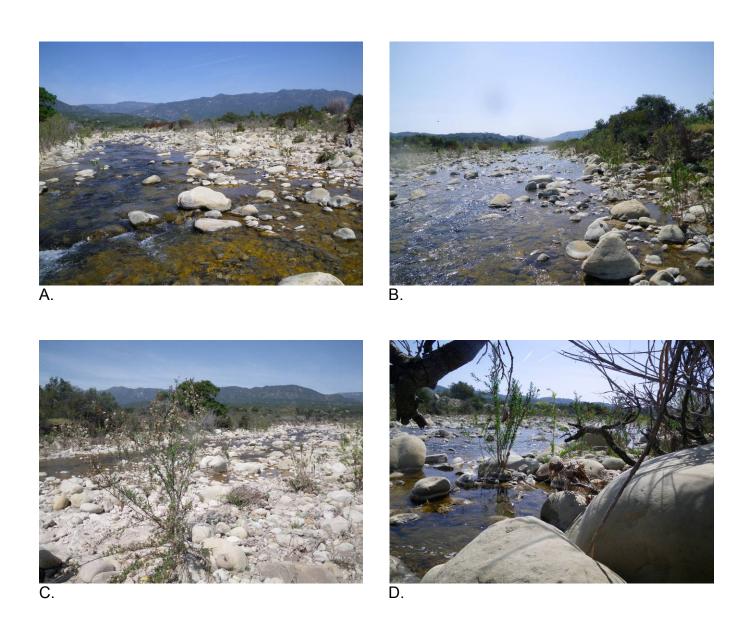
Appendix 15f. Photos of Site 7 impediment on 26 April 2011 during 31 cfs discharge release from Robles Fish Facility, looking from: (A) downstream, (B) upstream, (C) right to left bank, and (D) left to right bank.

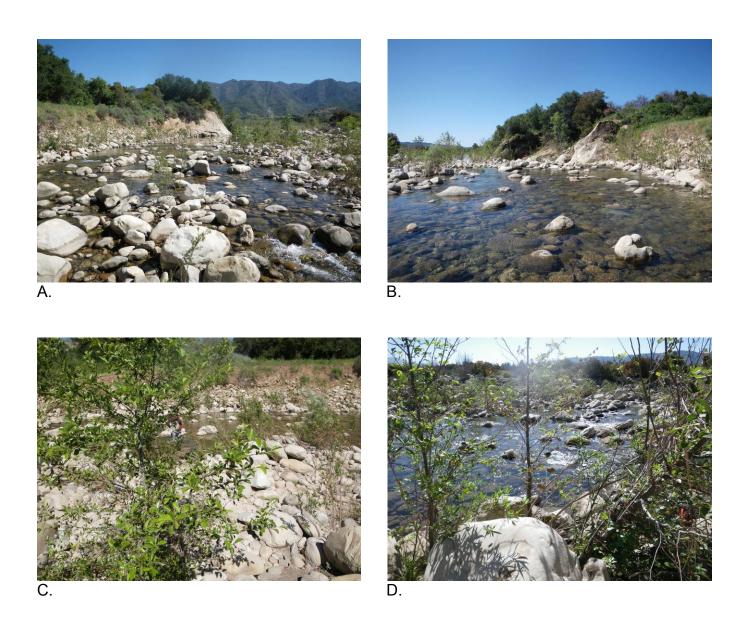
Appendix 15g. Photos of Site 8 impediment on 26 April 2011 during 31 cfs discharge release from Robles Fish Facility, looking from: (A) downstream, (B) upstream, (C) right to left bank, and (D) left to right bank.

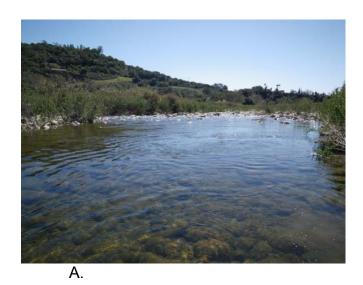
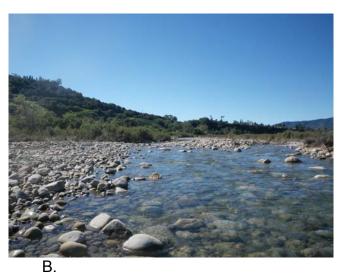
Appendix 15h. Photos of Site 6 impediment Site 6 looking downstream on 09 March 2011 (A) during 36 cfs discharge release from Robles Fish Facility and looking downstream from similar location on 01 April 2011 (B) during 39 cfs.

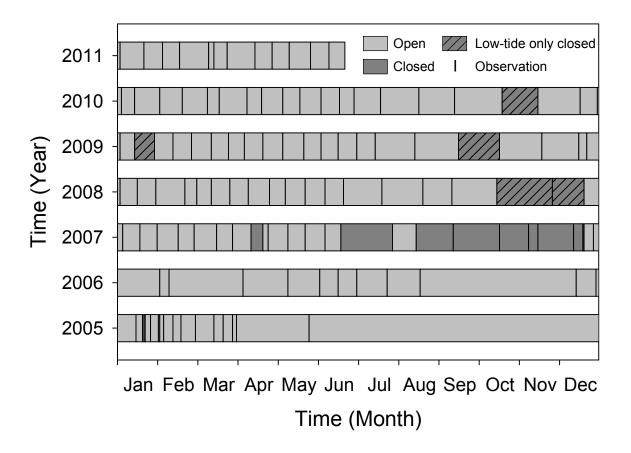
Appendix 21. Sandbar status at the mouth of the Ventura River from 2005 through June of 2011. Each observation is indicated by vertical lines and the sandbar status was assumed to remain the same until the next observation (Lewis et al. 2010).

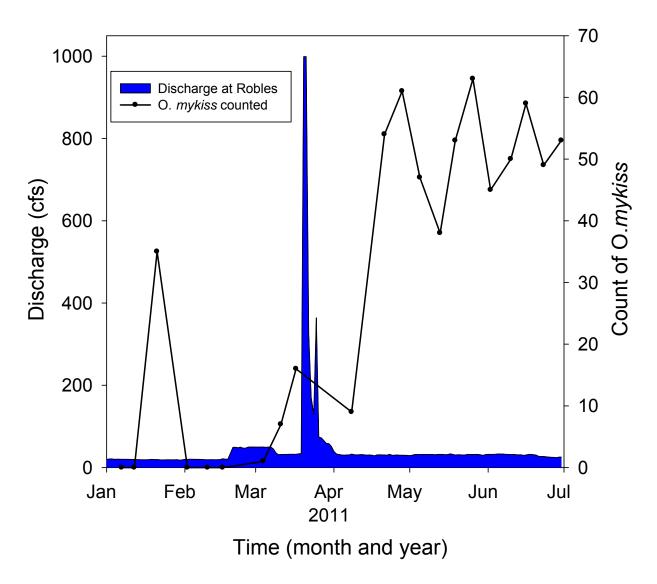
Appendix 23. Total count of *O. mykiss* observed during fish attraction surveys during the fish passage season from January through June 2011 and discharge from the Robles Facility.

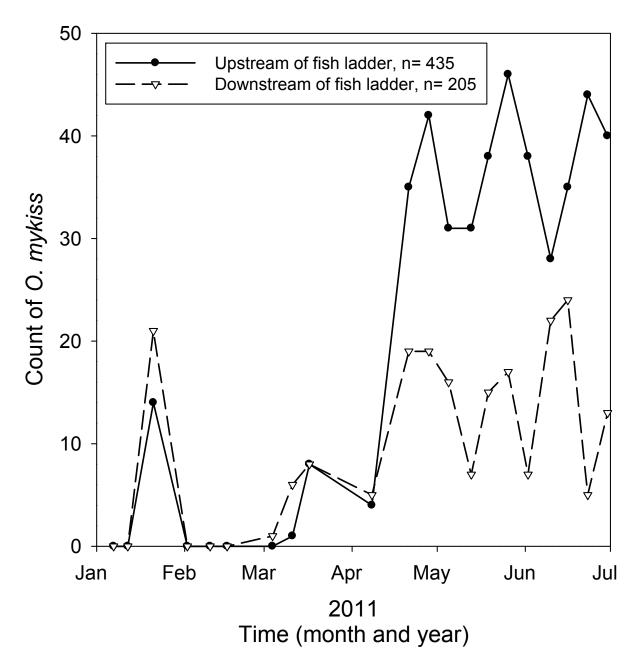
Appendix 24. Count of *O. mykiss* observed during fish attraction surveys upstream and downstream of the Robles Fish Facility during the fish passage season from January through June 2011.

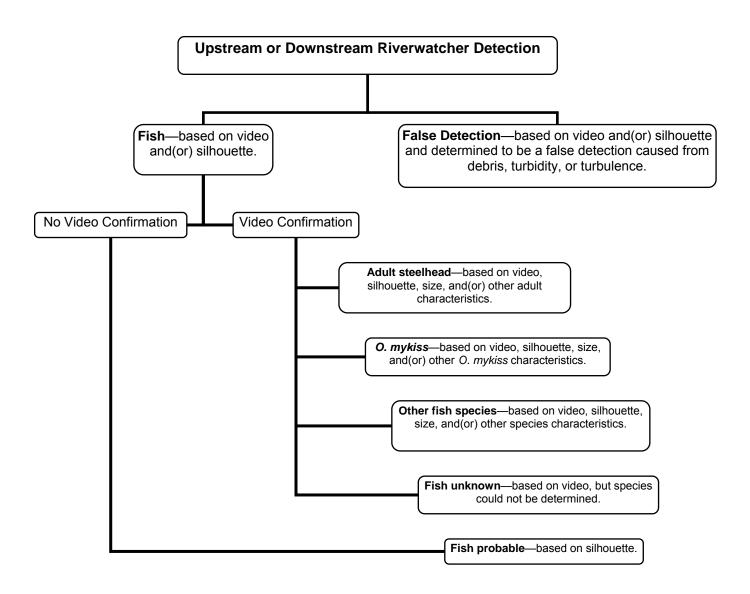
Appendix 25. Riverwatcher detection classification flow chart that outlines the pathways for upstream and downstream detections.

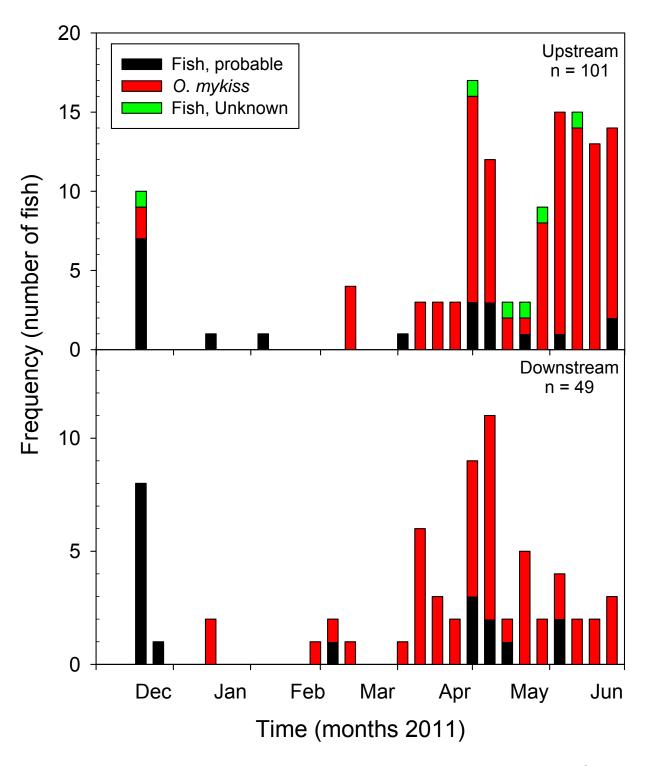
Appendix 27. Weekly Riverwatcher upstream and downstream detections classified as *O. mykiss*, fish probable, and fish unknown from January through June of 2011.

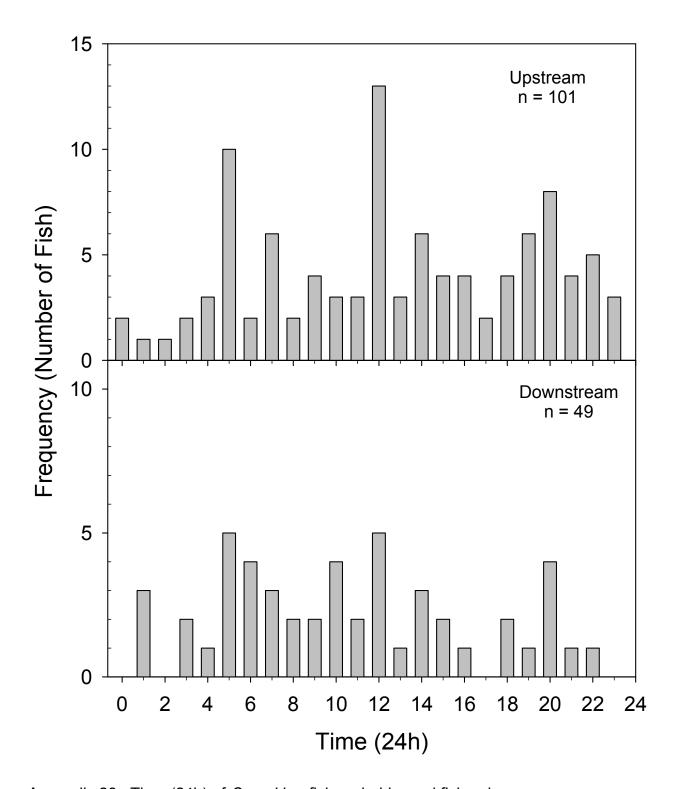
Appendix 28. Time (24h) of *O. mykiss,* fish probable, and fish unknown passage through the Riverwatcher in upstream and downstream directions from January through June of 2011.

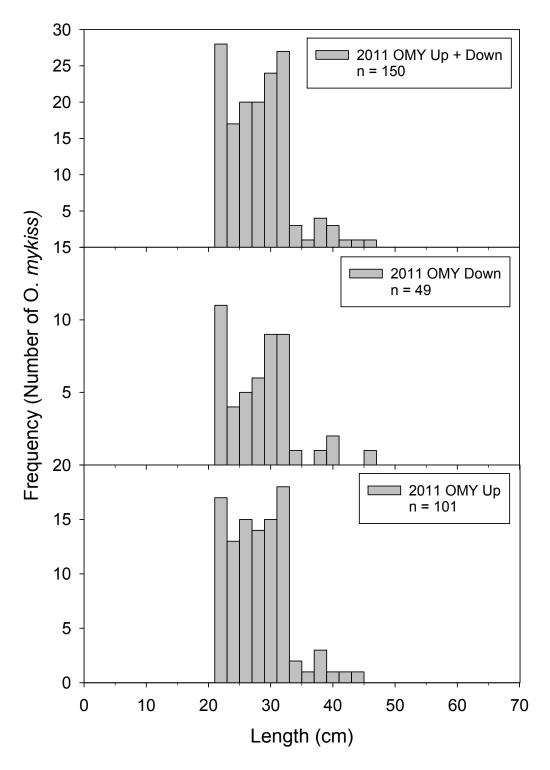
Appendix 29. Length frequency distribution of *O. mykiss* detected passing through the Riverwatcher from January through June of 2011.

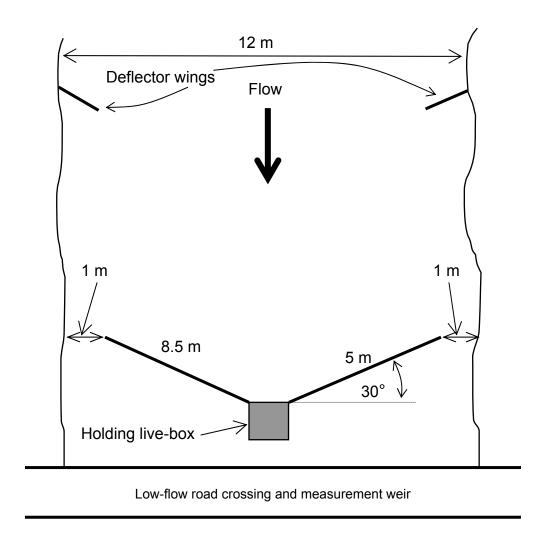
Appendix 31. Top view of downstream migrant smolt trap layout in the Ventura River below the Robles Fish Facility.

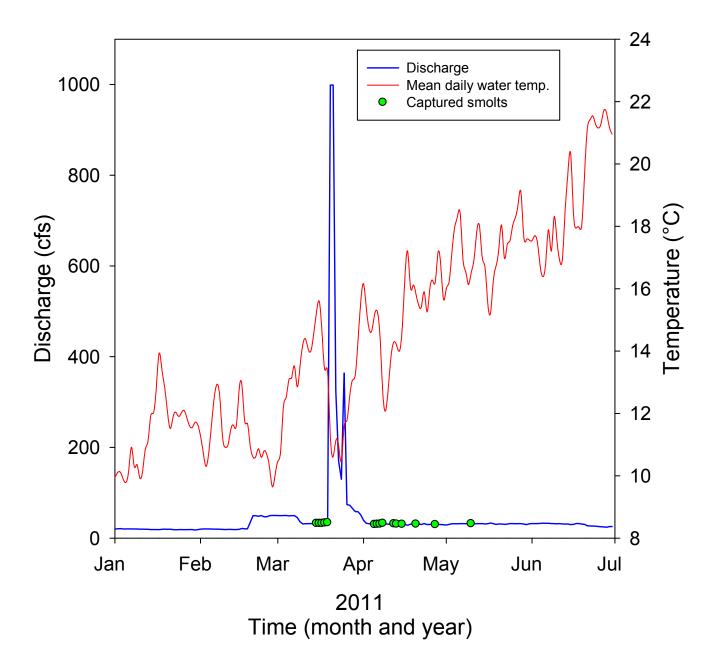
Appendix 33. Mean daily water temperature, mean daily discharge, and time of capture for smolts in the weir trap downstream of the Robles Fish Facility in 2011.

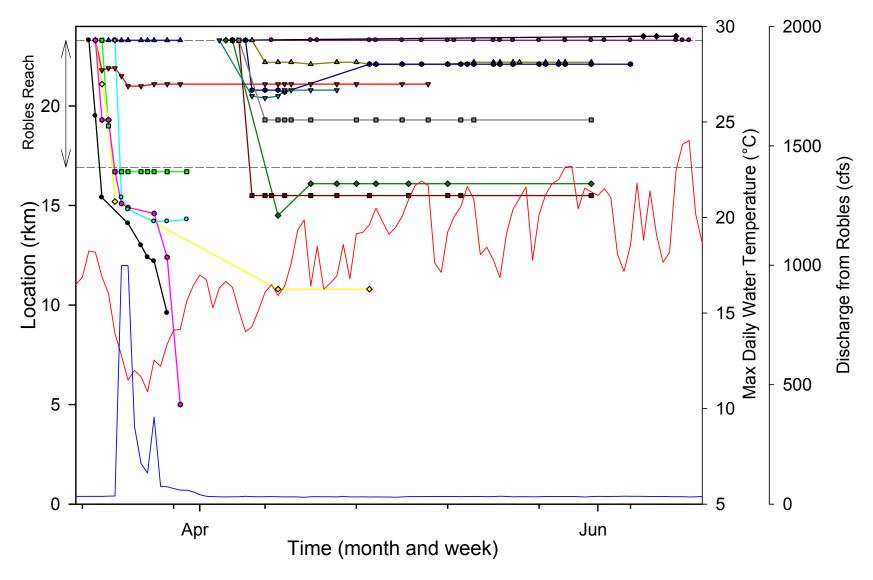
Appendix 34. Location and date of radio-tagged *O. mykiss* smolts released downstream of the Robles Fish Facility in March and April of 2011. Red line is maximum daily water temperature downstream of the Robles Fish Facility and the blue line is discharge from Robles. The Robles Reach is indicated by the two horizontal dashed lines.

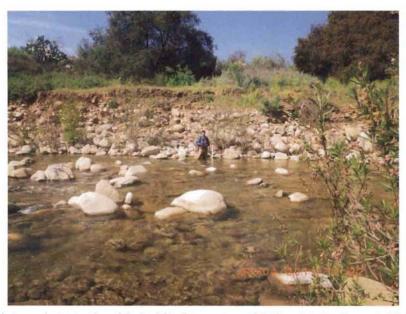
Figure 1. Approximate location of Casitas' Site 8 transect near OVLC pools in boulder run habitat. Person on West bank positioned at GPS coordinate from Casitas' Table 2 (34°12'15", 119°17'36").

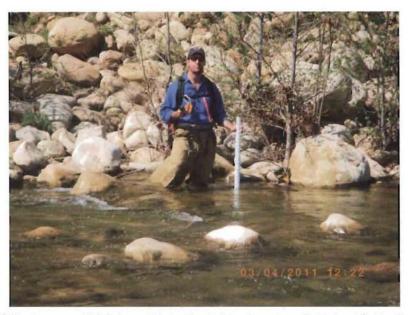
Figure 2. Depth measured 2.0-ft deep at this location (1.2-km downstream Robles) and Robles discharge was 50-cfs. All transect stream depths perpendicular to streamflow measured greater than 0.6-ft deep.
