**DECLARATION OF CASITAS  
MUNICIPAL WATER DISTRICT  
ASSISTANT GENERAL MANAGER  
KELLEY DYER IN SUPPORT OF JOINT  
APPLICATION TO SET A HEARING  
DATE FOR AN INTERIM ORDER  
REGARDING THE PHYSICAL SOLUTION  
AND TO CONTINUE THE STAY UNTIL  
THE HEARING DATE**

**DECLARATION OF KELLEY DYER**

13           6. Attached hereto as Exhibit 2 are true and correct copies of representative Robles  
14 Facility Progress reports that Casitas, per the Biological Opinion, submitted in 2008, 2010, 2012,  
15 2019, and 2020. These reports, which are representative of different water year types, contain key  
16 information that the Watershed Parties and the State will need to consider as they develop the  
17 permanent physical solution, including: (a) in-channel passage conditions; (b) natural surface  
18 water connections; (c) river discharges when adult steelhead have migrated upstream, seasonal and  
19 diel migration behavior; (d) detail of successful reestablishment of adult steelhead to historic  
20 spawning and rearing habitat through passage at the Robles Fish Passage Facility; and (e) the  
21 cyclic nature of *O. mykiss* abundance vis-à-vis precipitation in the Ventura River Watersh

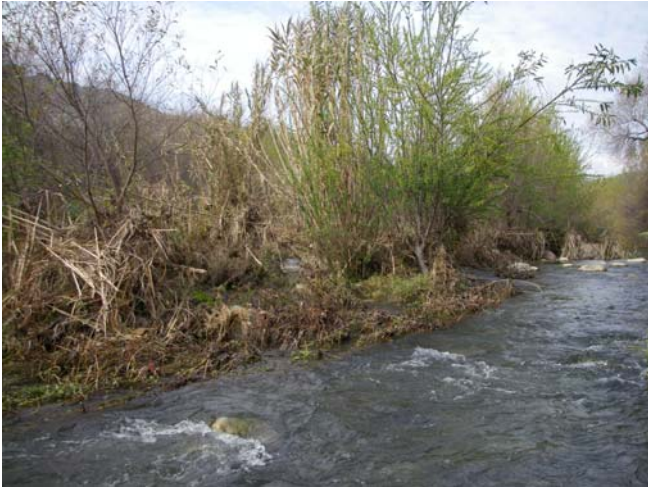
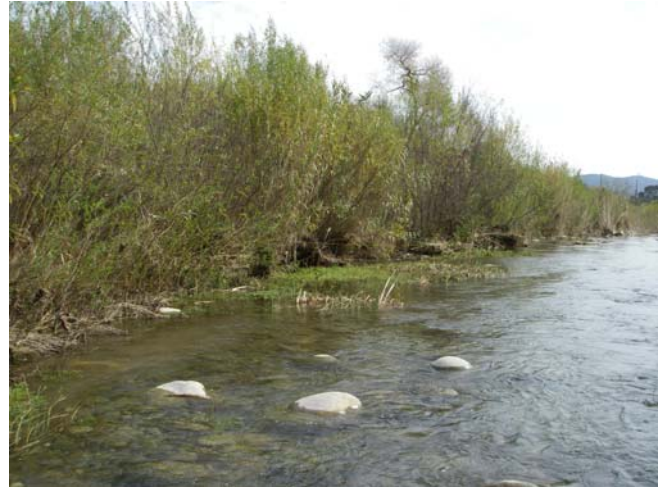
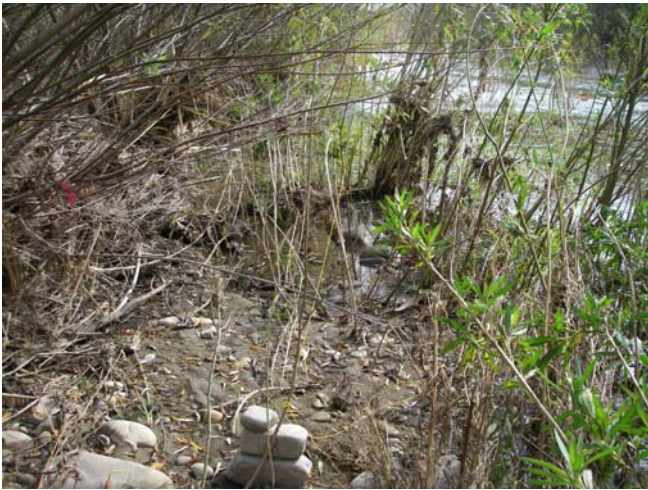
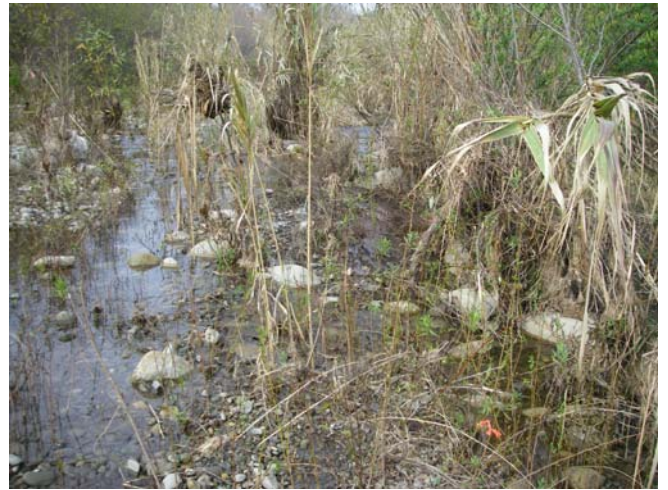
Appendix 10a. Photos of impediment site number 2 on February 2, 2010 during 40 cfs discharge releases from Robles fish facility, looking from: (A) downstream, (B) upstream, (C) right to left bank, and (D) left to right bank.

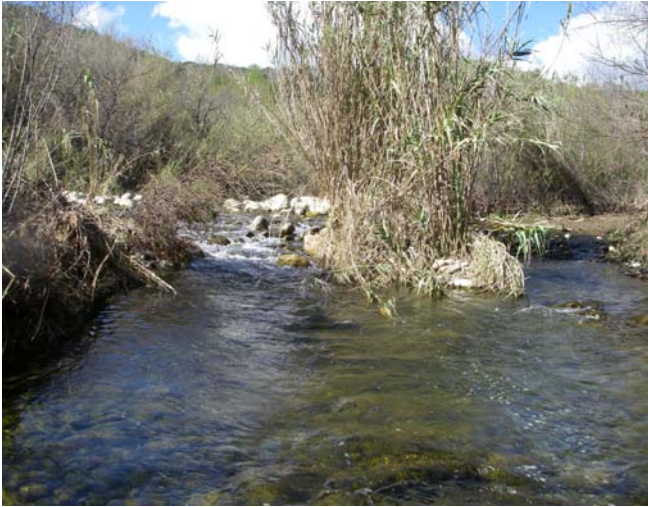
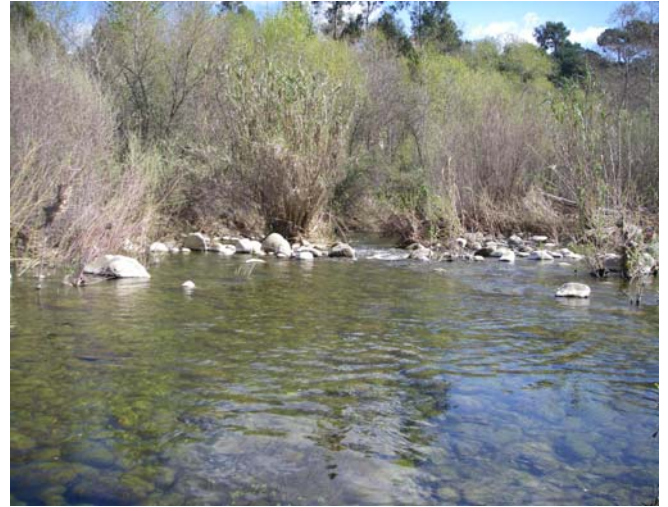
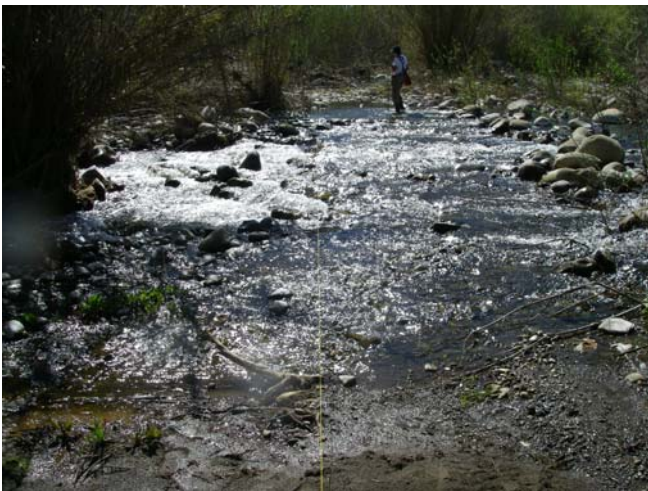
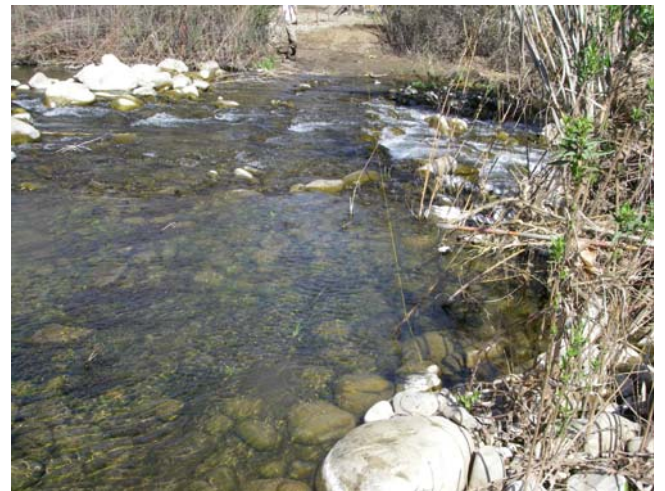
Appendix 10c. Photos of impediment site number 4 on February 22, 2010 during 30 cfs discharge release from Robles fish facility, looking from: (A) downstream, (B) upstream, (C) right to left bank, and (D) left to right bank.

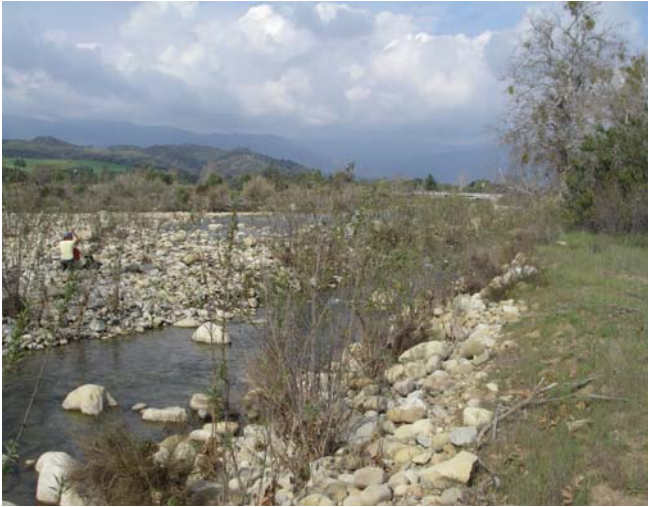
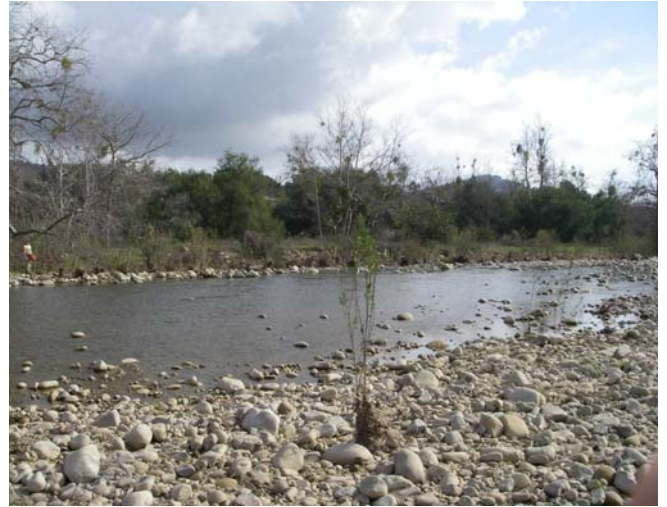
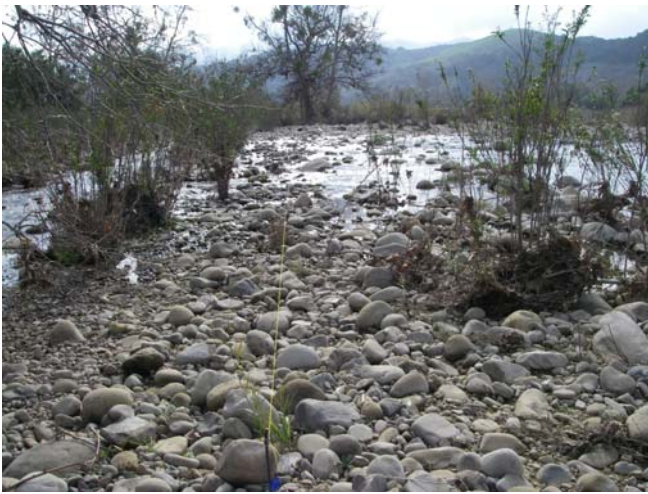
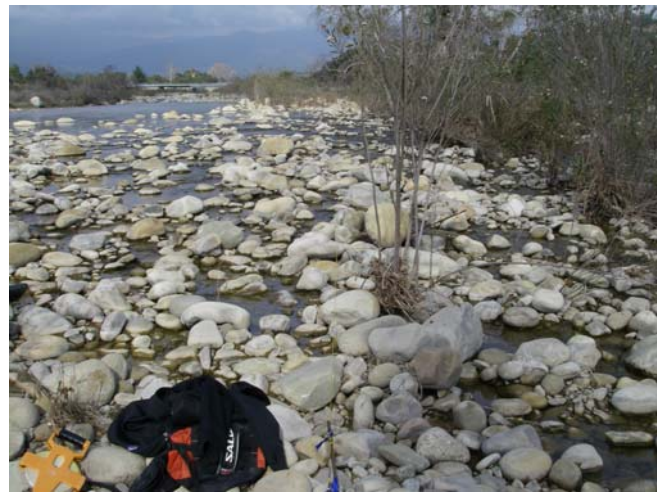
Appendix 10d. Photos of potential impediment site number 5-1 on February 04, 2010 during 30 cfs discharge release from Robles fish facility, looking from: (A) downstream, (B) upstream, (C) right to left bank, and (D) left to right bank.

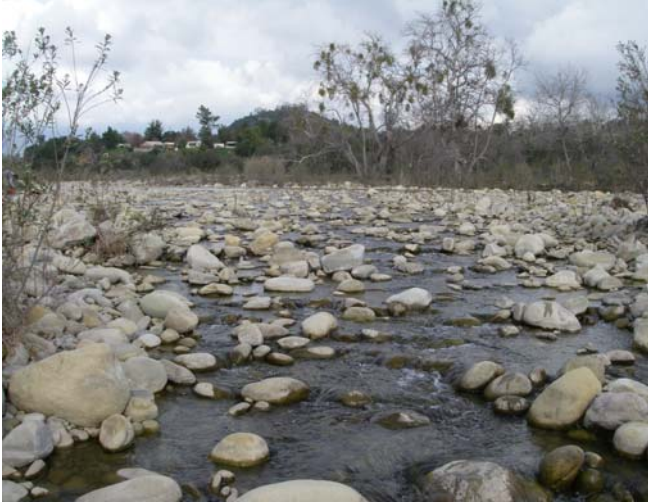
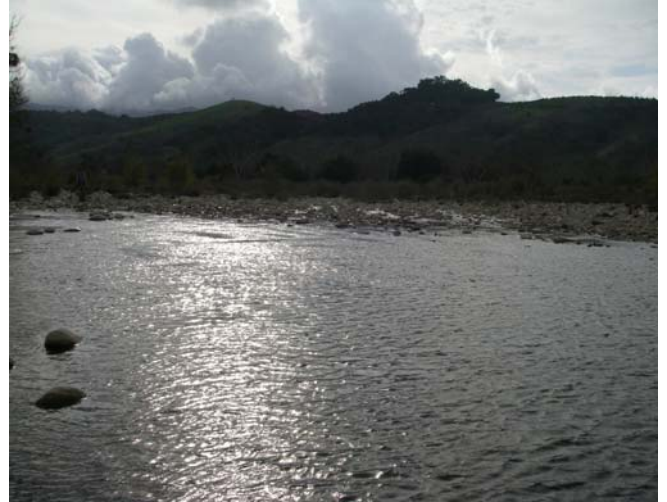
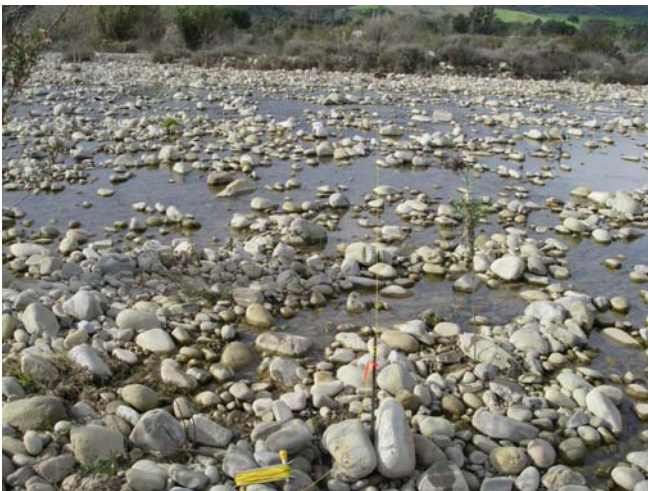
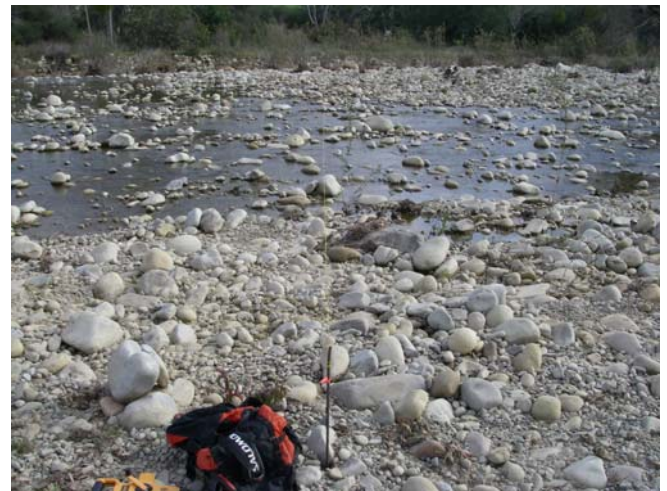
Appendix 10e. Photos of potential impediment site number 5-2 on February 04, 2010 during 30 cfs discharge release from Robles fish facility, looking from: (A) downstream, (B) upstream, (C) right to left bank, and (D) left to right bank.

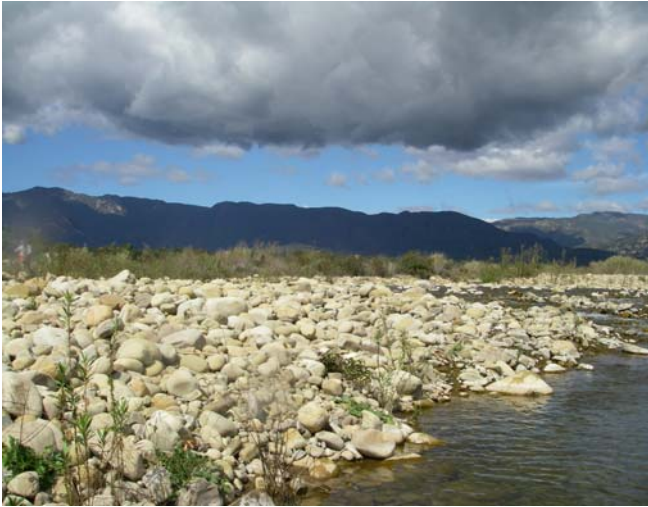
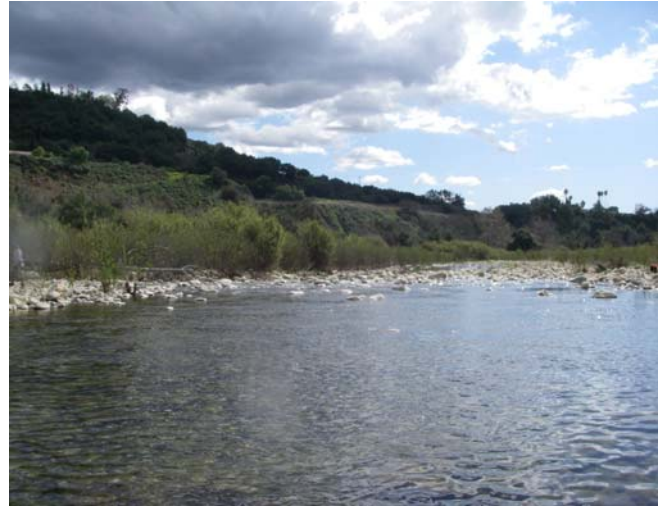
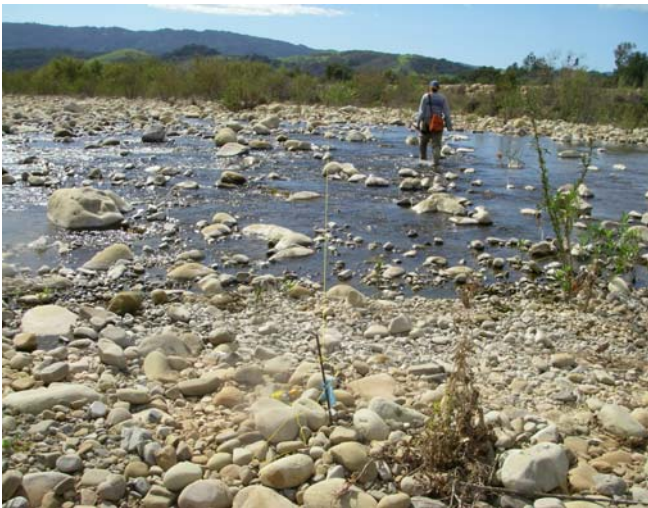
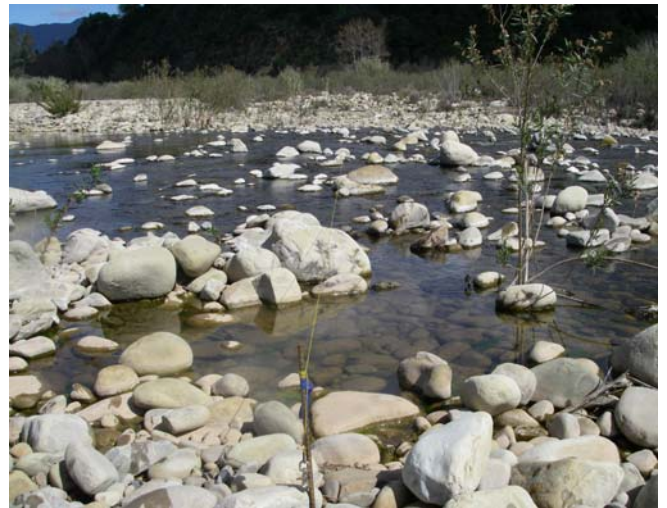
Appendix 10f. Photos of impediment site number 6 on February 22, 2010 during 30 cfs discharge release from Robles fish facility, looking from: (A) downstream, (B) upstream, (C) right to left bank, and (D) left to right bank.

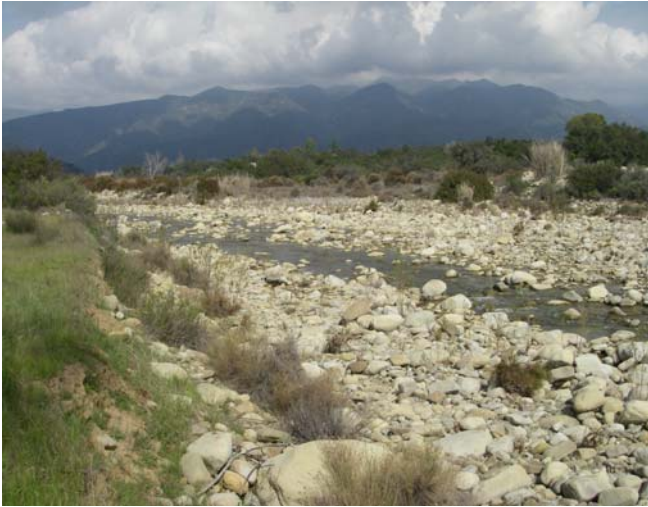
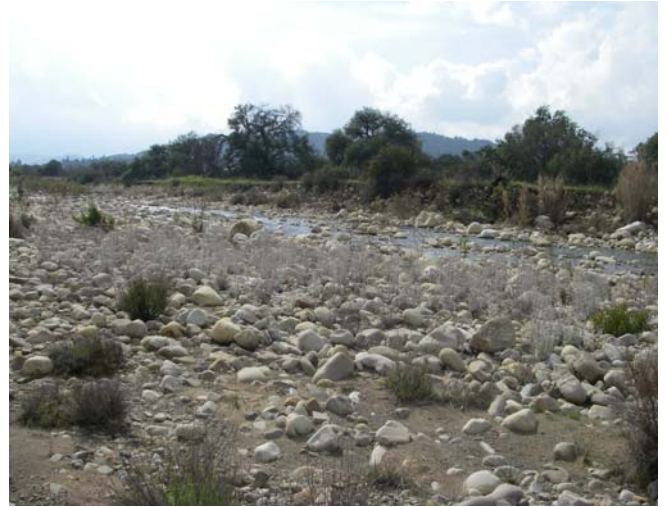
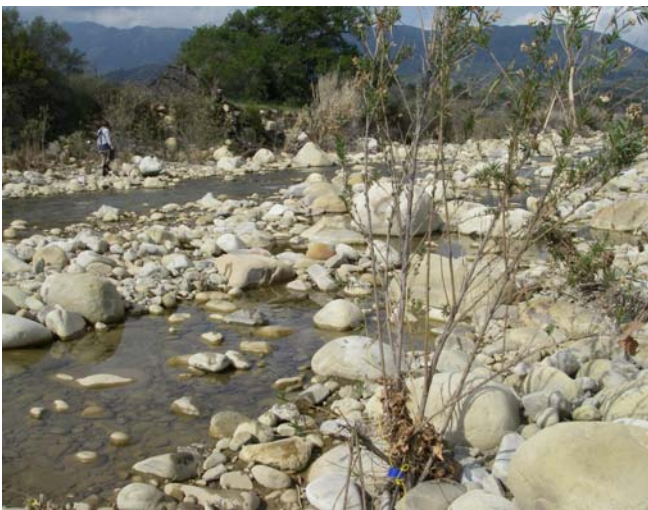
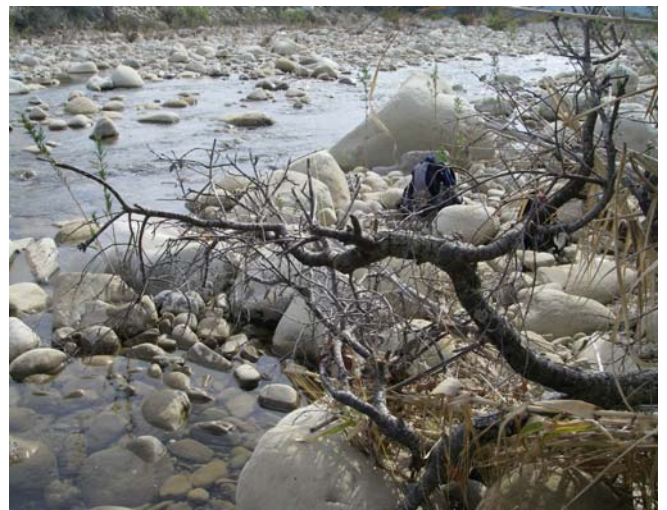
Appendix 10g. Photos of impediment site number 7 on February 04, 2010 during 30 cfs discharge release from Robles fish facility, looking from: (A) downstream, (B) upstream, (C) right to left bank, and (D) left to right bank.

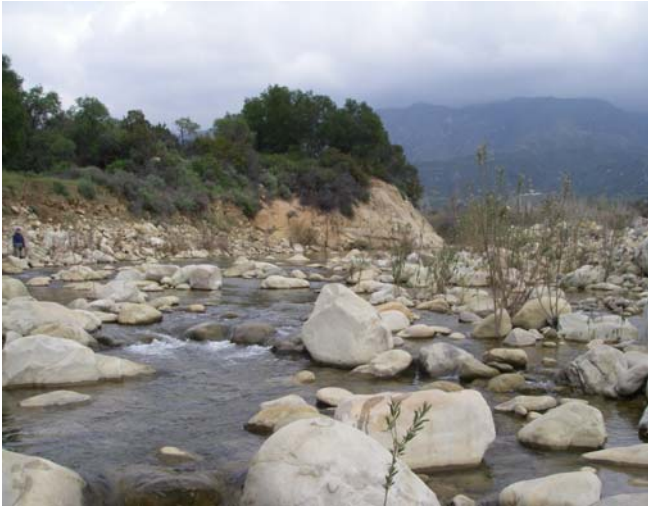
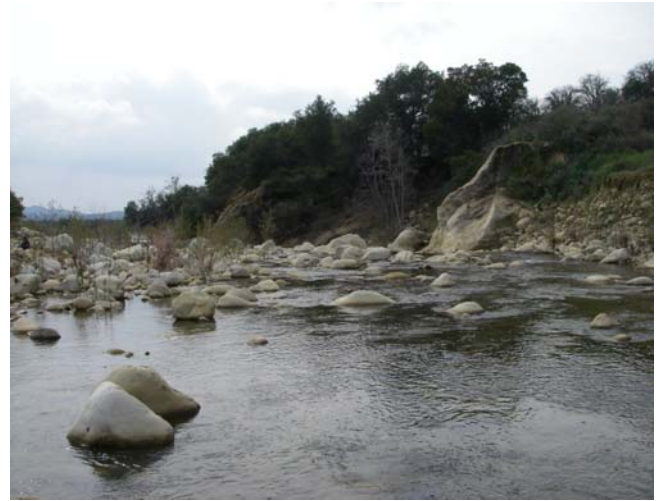
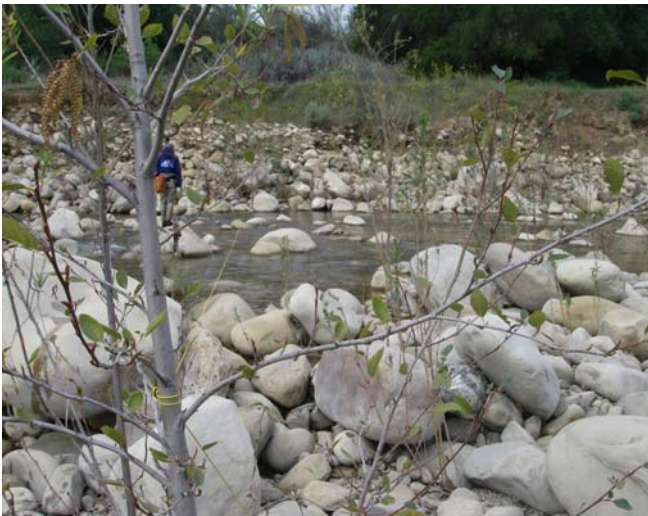
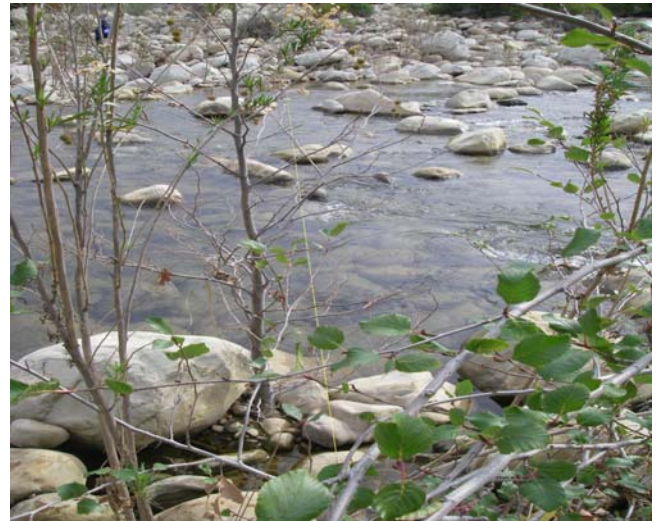
Appendix 10h. Photos of impediment site number 8 on February 04, 2010 during 30 cfs discharge release from Robles fish facility, looking from: (A) downstream, (B) upstream, (C) right to left bank, and (D) left to right bank.

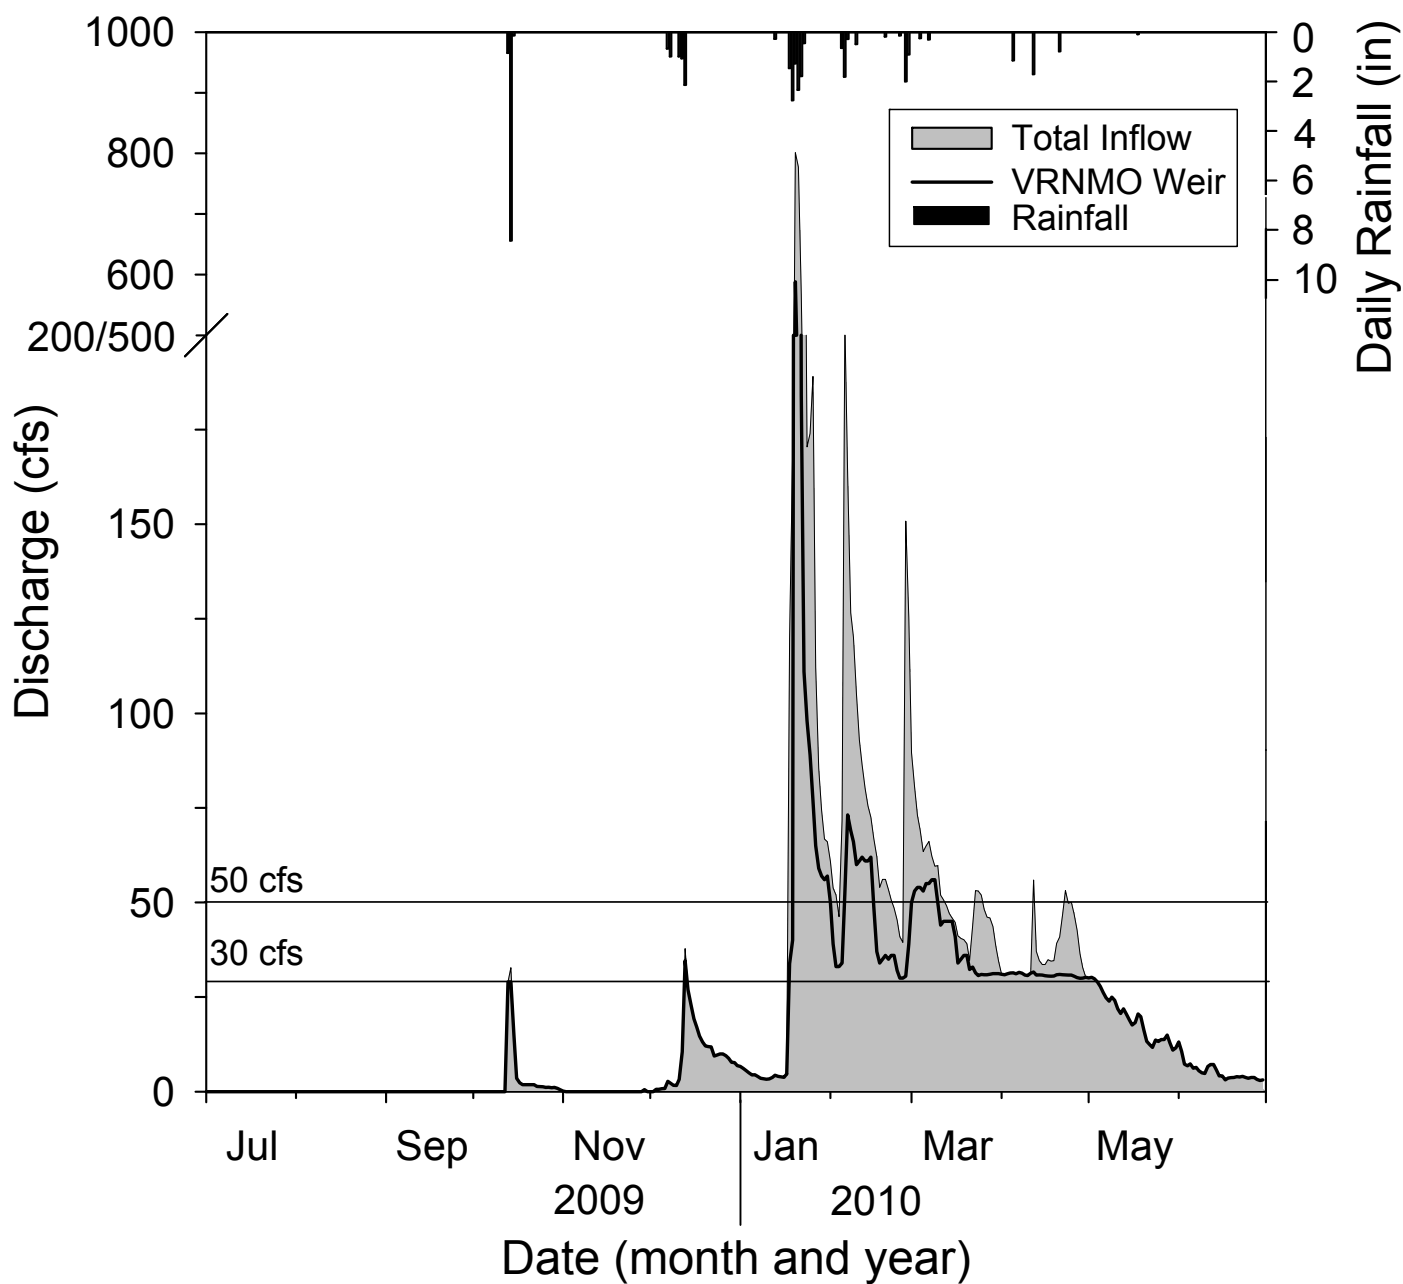
Appendix 28. Total inflow to Robles Fish Passage Facility, discharge downstream at measurement weir, and precipitation during the reporting period.

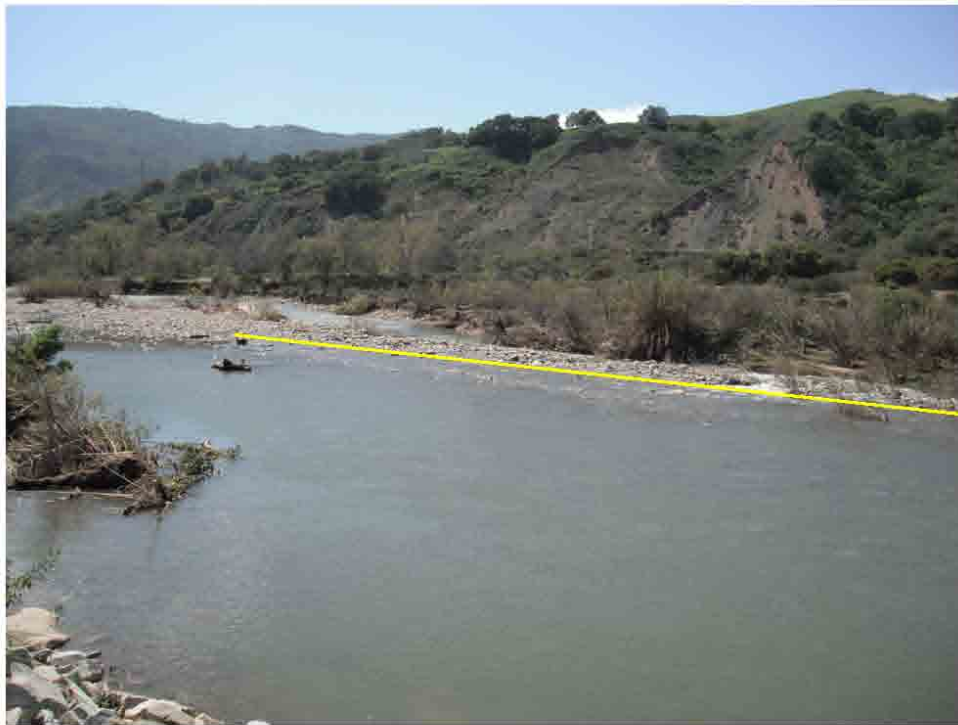
Photo 1. Photo of new site 3 looking downstream. Water is moving from right to left and across the transverse riffle/rapid. The yellow line represents approximate location of transect.

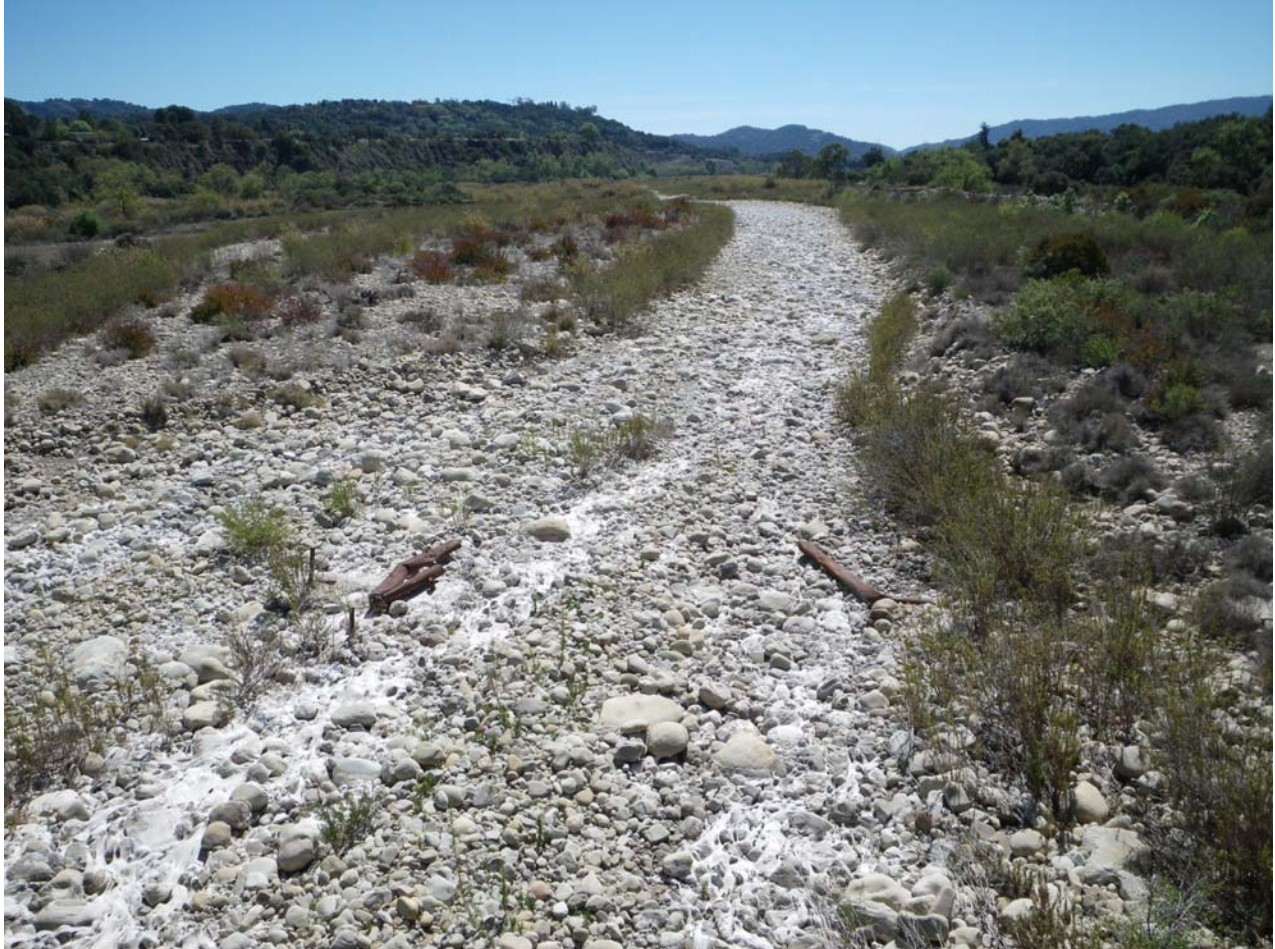
Ventura River channel in the Robles Reach downstream of Hwy 150 during March of 2012. Due to low precipitation, the river channel was dry throughout the steelhead migration season.

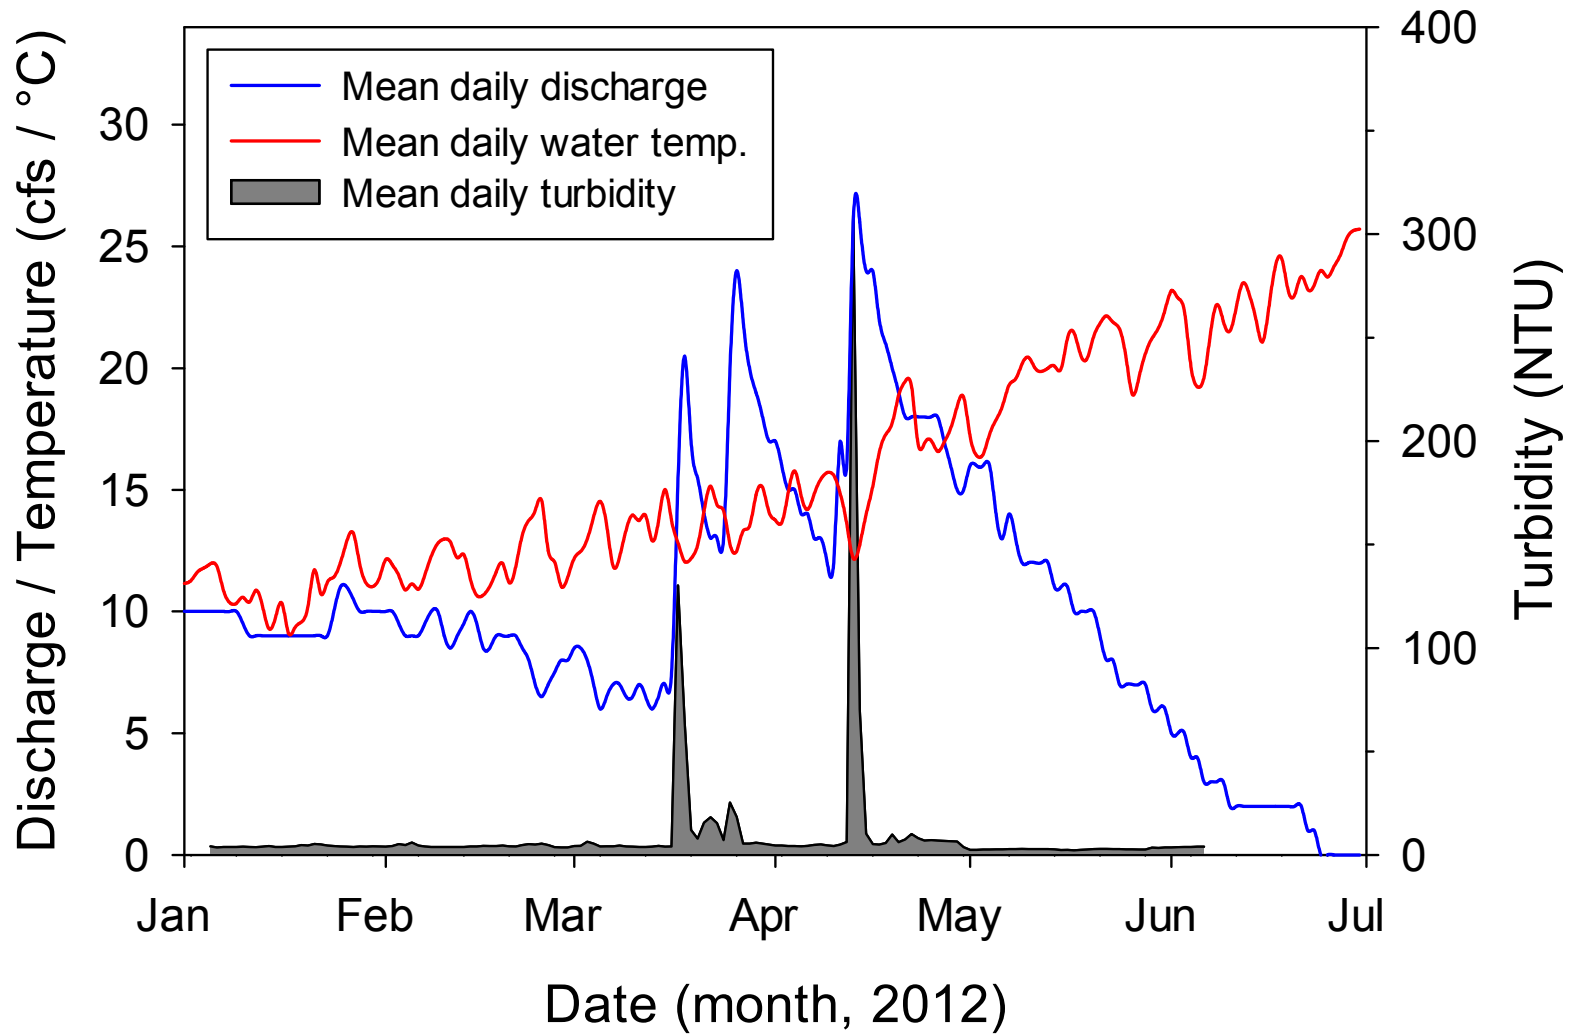
Appendix 16. Mean daily discharge, water temperature, and turbidity from the Robles Fish Facility during the fish passage season.

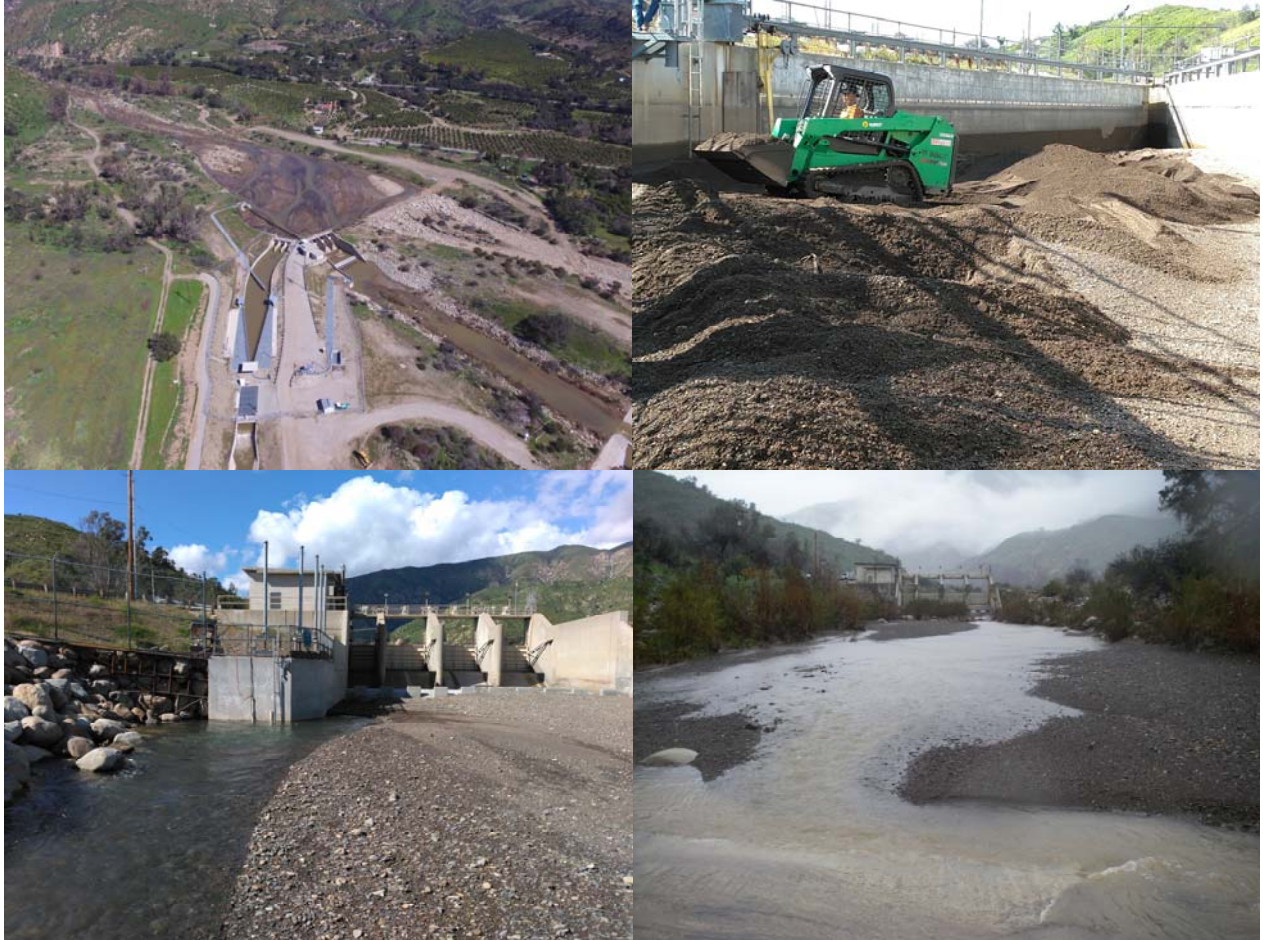
Storms during 2019 transported extensive Thomas Fire sediment downstream from the upper Ventura River basin. Sediment was transported into the Robles forebay until full, which then moved into the Robles Fish Passage Facility. Top left photo is aerial of Robles Facility showing sediment accumulation in forebay, top right is sediment removal process from screenbay, bottom left is sediment that filled in entrance pool (channel on left bank remained open because of fish ladder flows), and bottom right is showing sediment-filled channel upstream of the measurement weir.

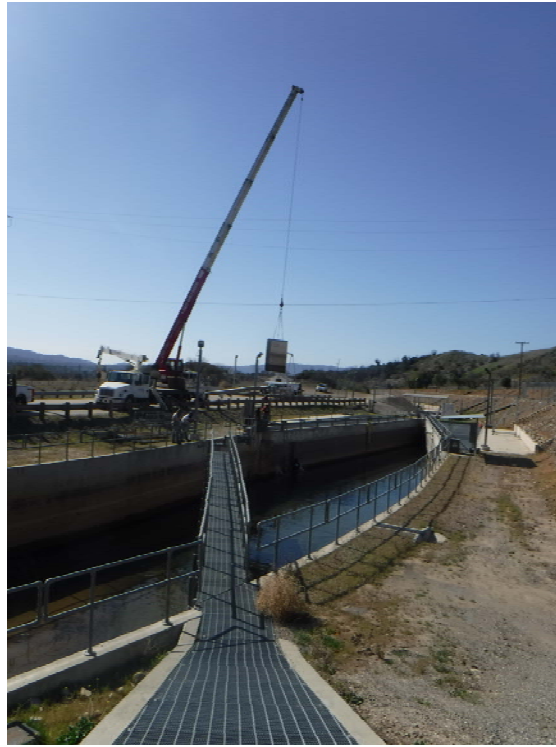
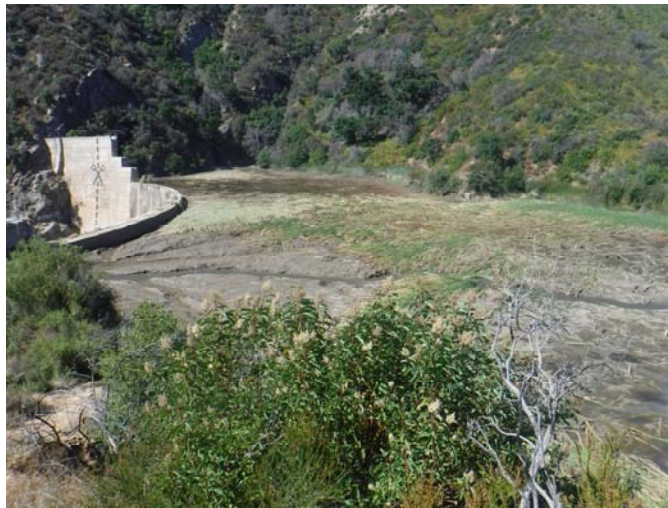
During 2020, a prototype evaluation study was initiated at the Robles Fish Passage Facility to compare several fish screen cleaning modifications. One prototype is a horizontal orientation wedge-wire fish screen that is being installation in the top photo. Matilija Reservoir was fully drained by Ventura County due to seismic and safety concerns and revealed the extensive sedimentation in the bottom photo.

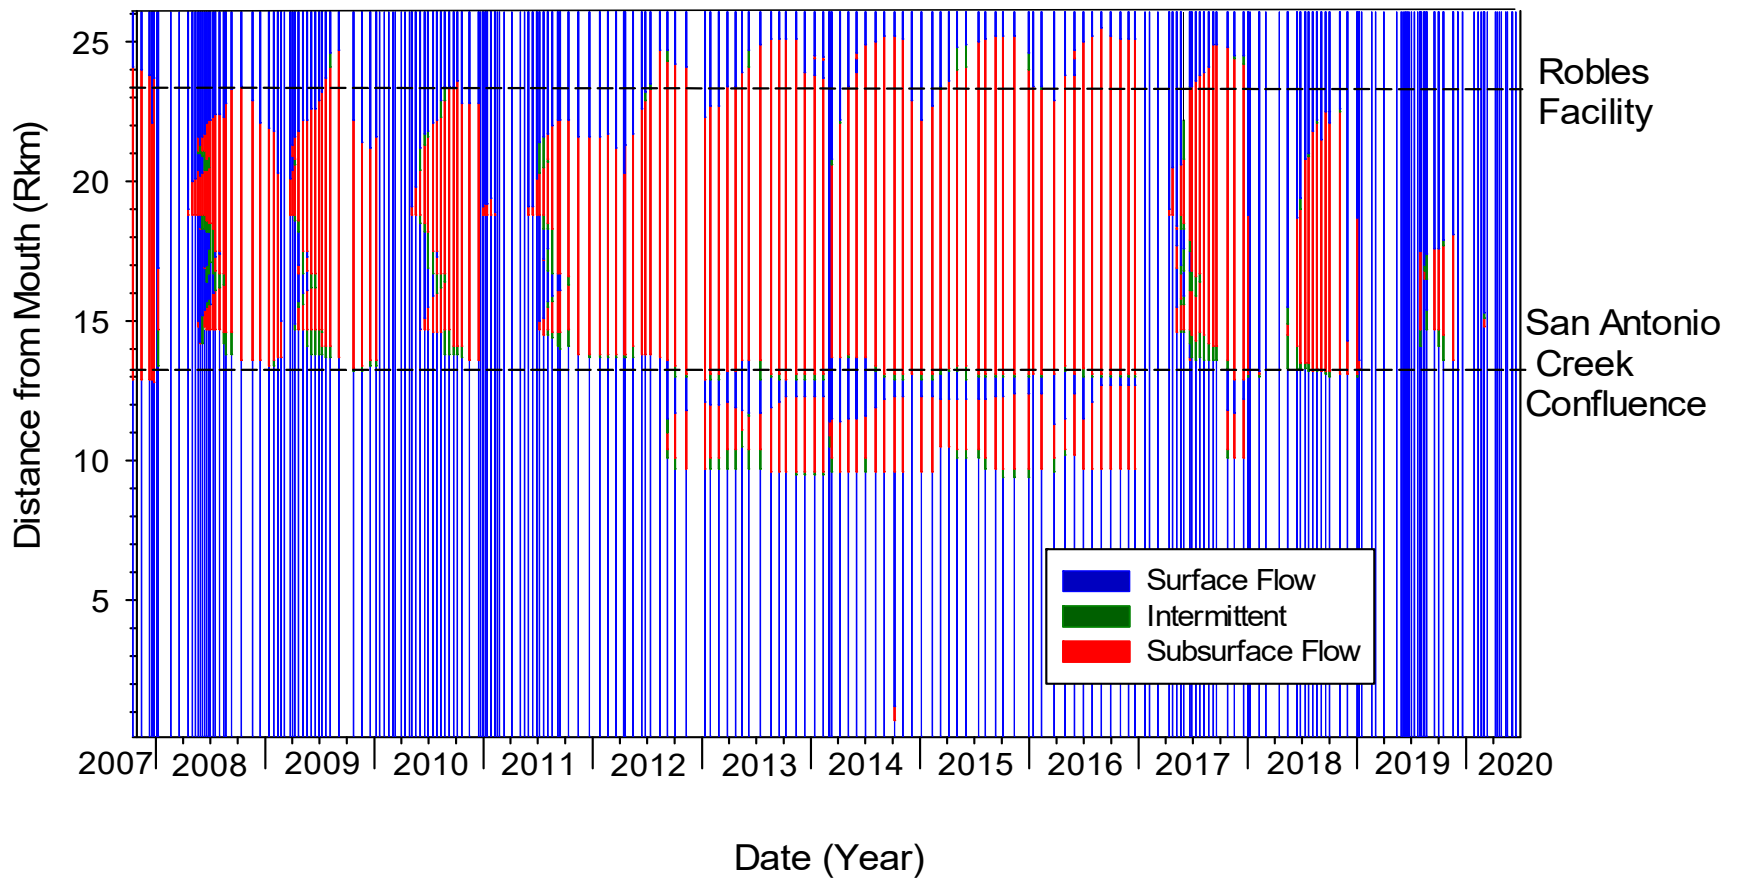
Appendix 32. Ventura River channel surface flow monitoring from 2008 to 2020.
