Board Meeting Agenda

CASITAS MUNICIPAL WATER DISTRICT
September 12, 2012
3:00 P.M. – DISTRICT OFFICE

2011 Robles Fish Passage Facility Progress Report

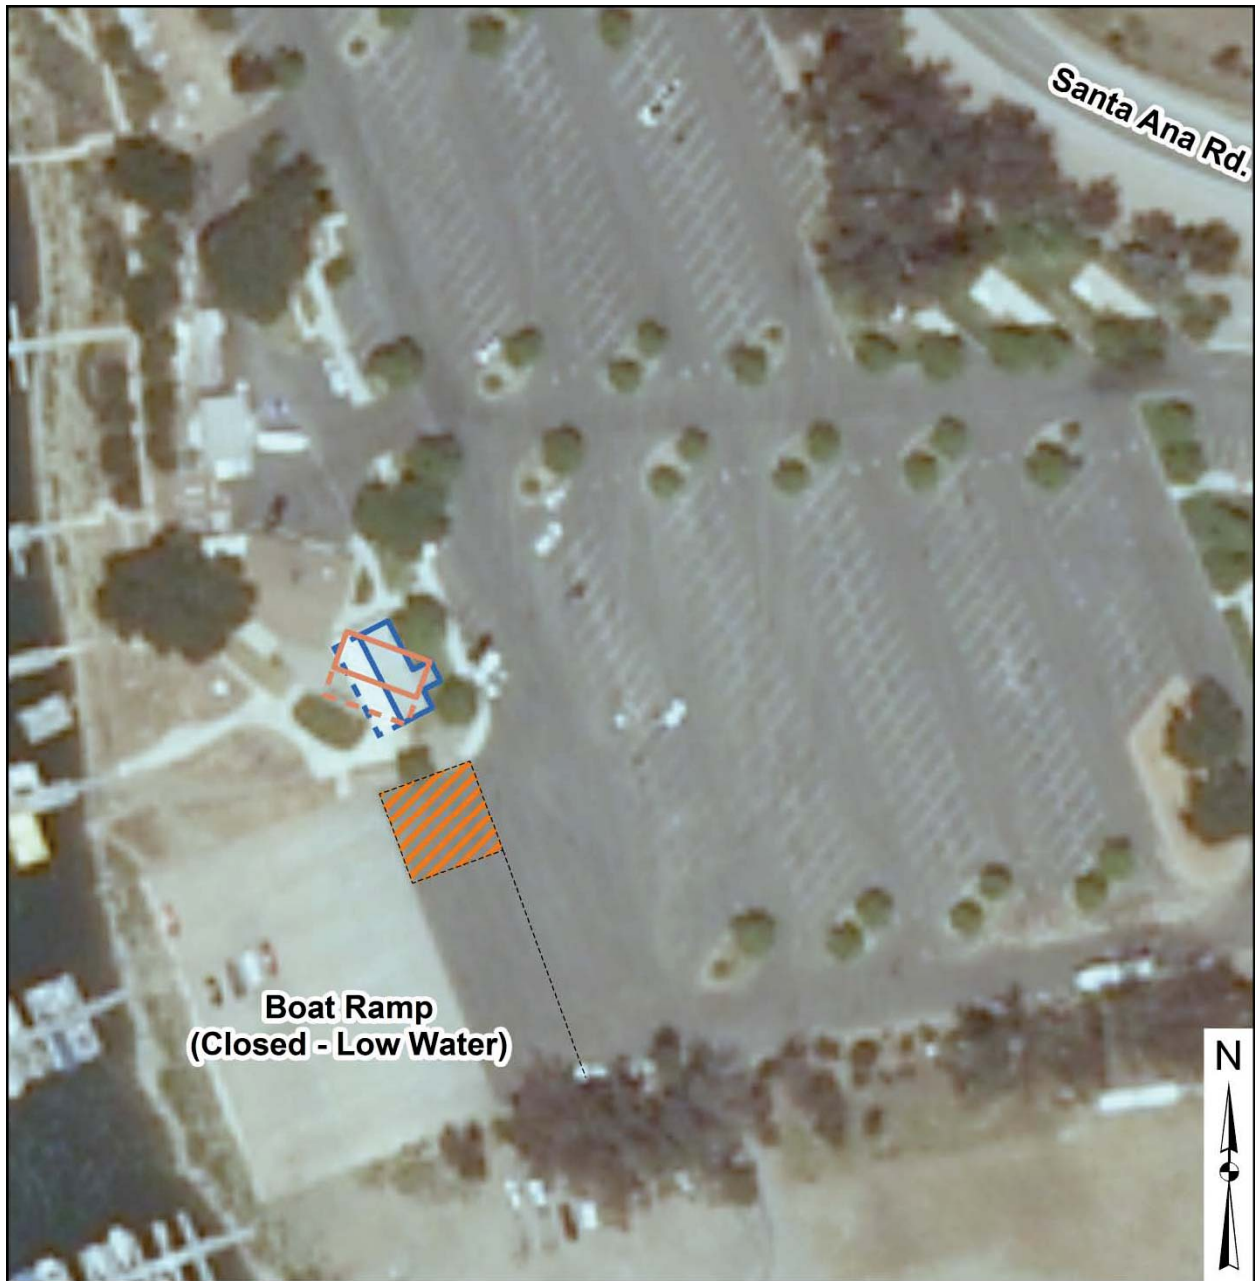
Figure 5 Conceptual Construction Plan

It is recommended the Board review and approve the project. If approved and after it clears the Reclamation NEPA team, we anticipate completion sometime this winter or early spring 2013.

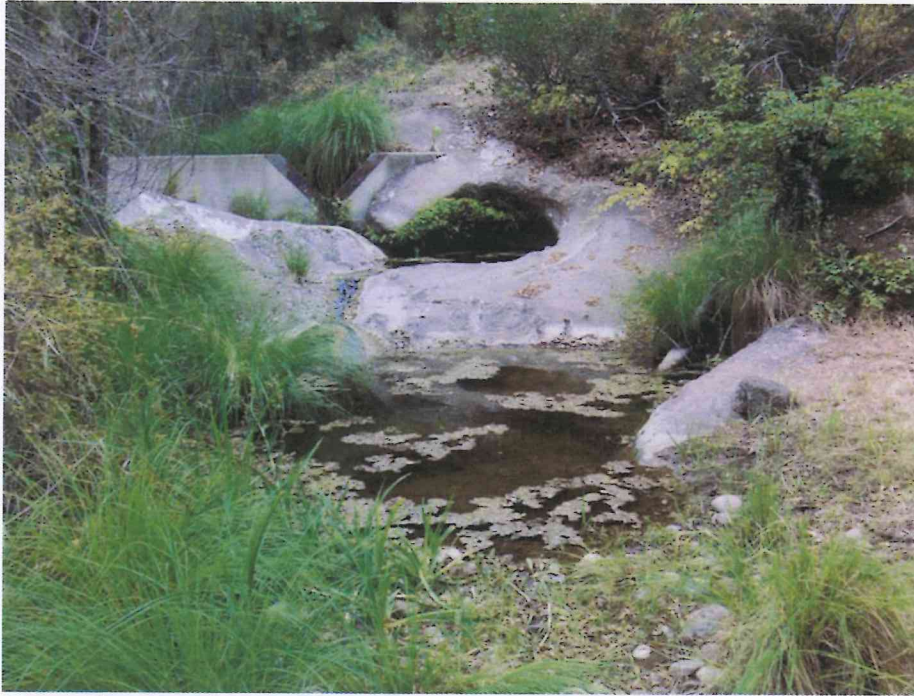
Photograph 3. Pools at upper end of Cooper Canyon tributary

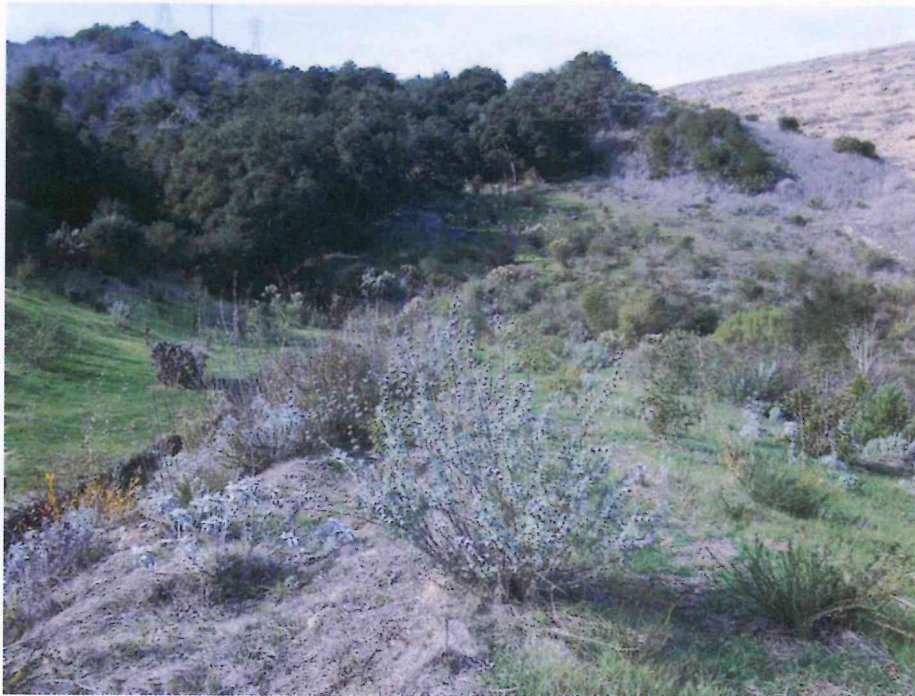
Photograph 4. Oak woodland restoration site near Casitas Dam

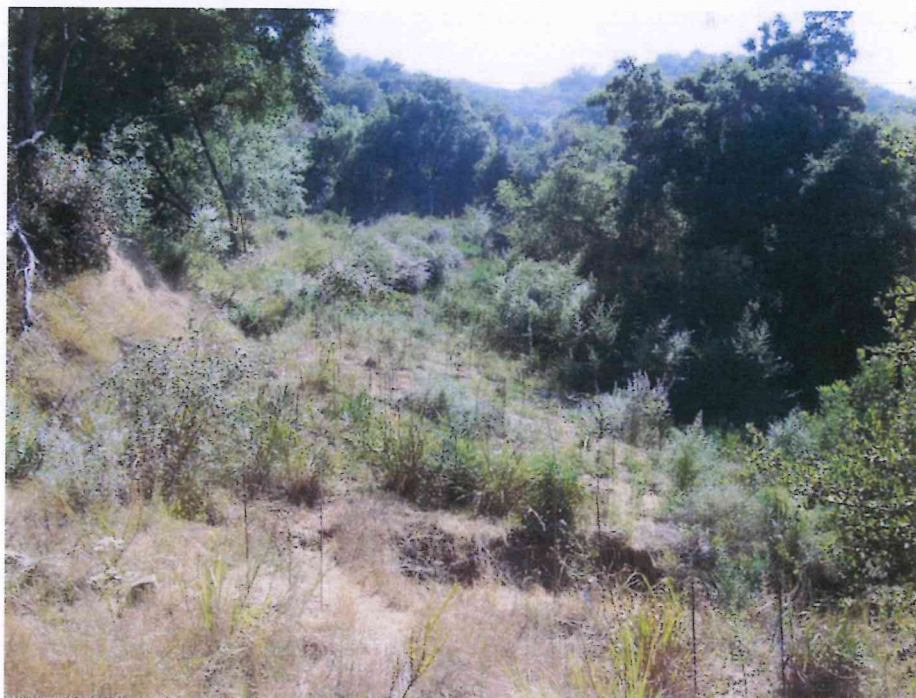
Photograph 5. Oak woodland restoration site near Casitas Dam

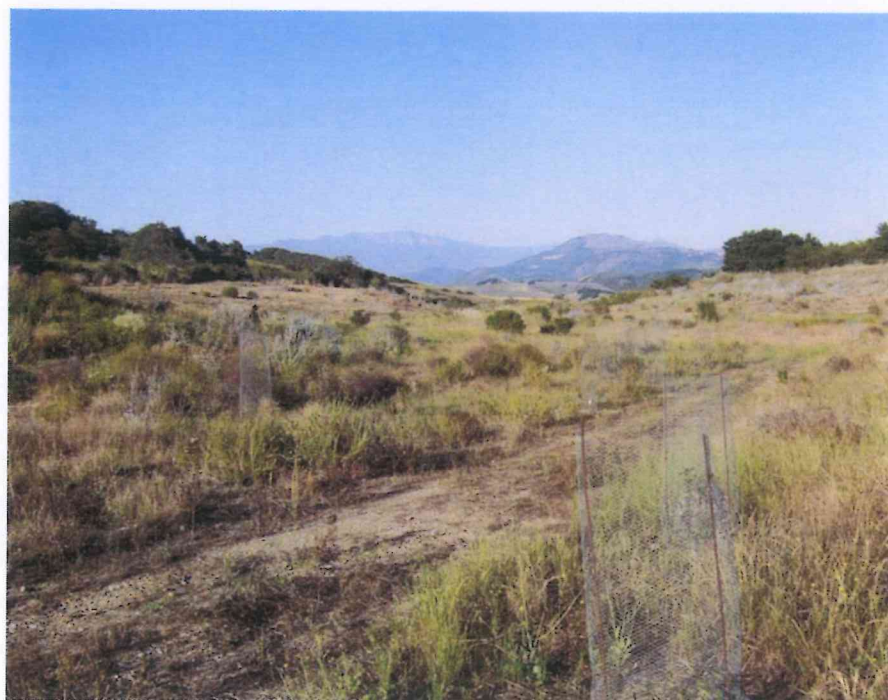
Photograph 6. View of the Borrow Site B Restoration Site

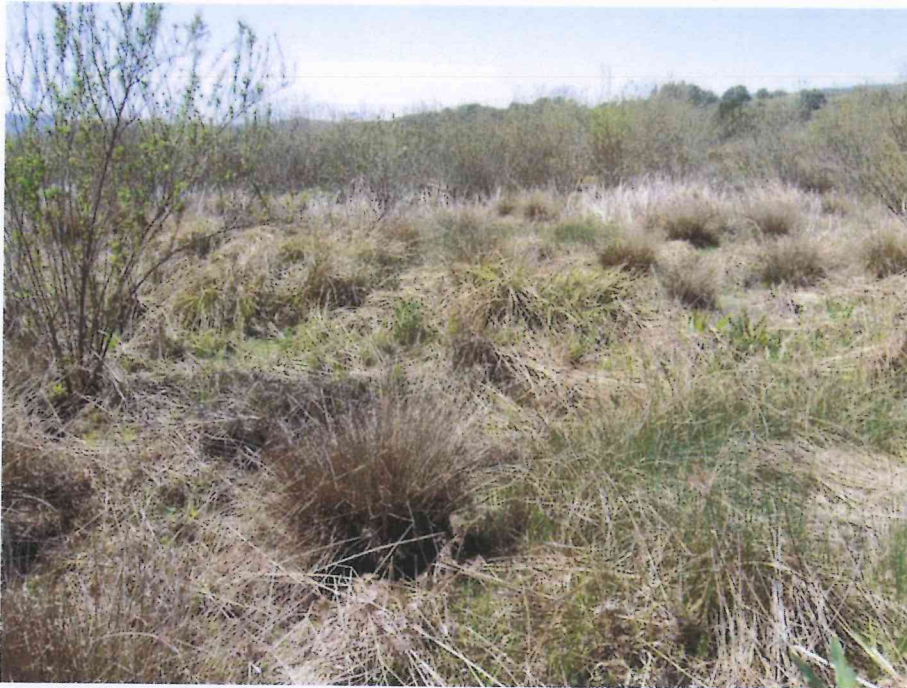
Photograph 7. View of wetland at the Casitas Wetland/Grassland Restoration Project Site (taken 3-23-07)

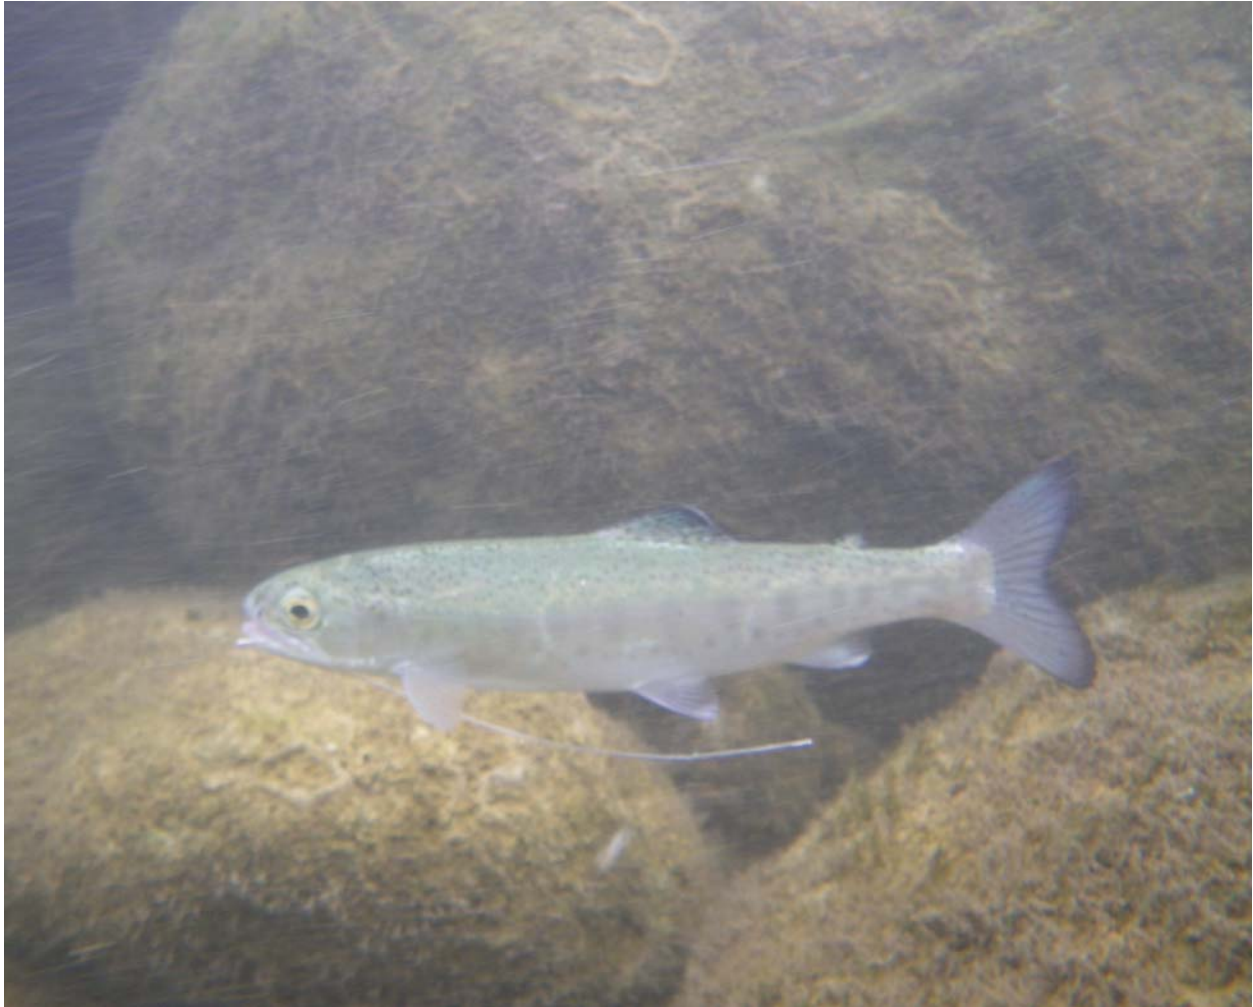
Steelhead smolt with gastric radio tag. Smolt was captured, tagged, and released downstream of the Robles Fish Facility in April 2011.

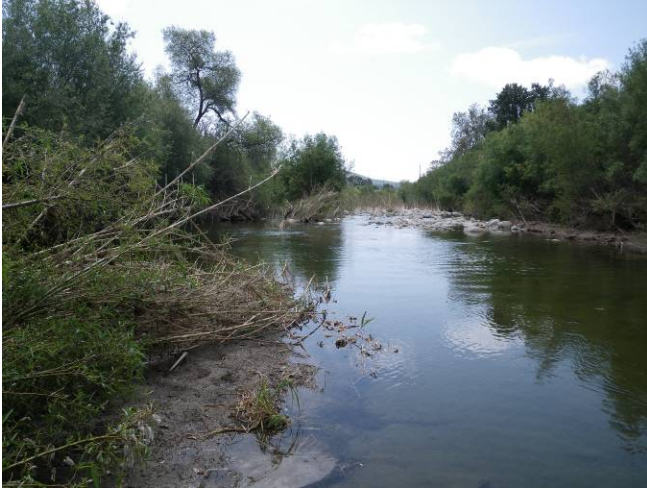
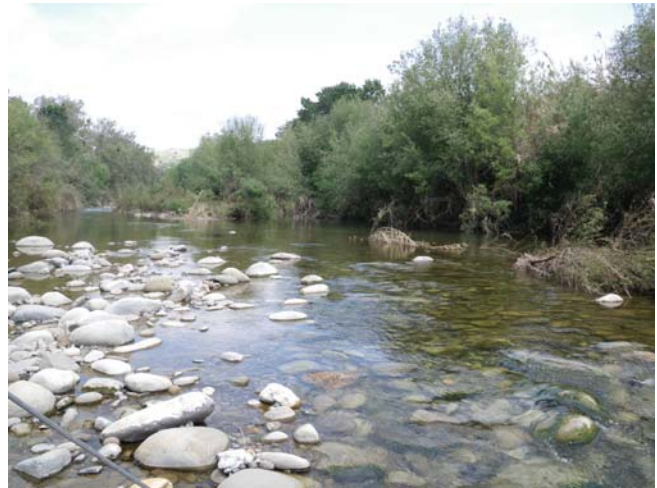
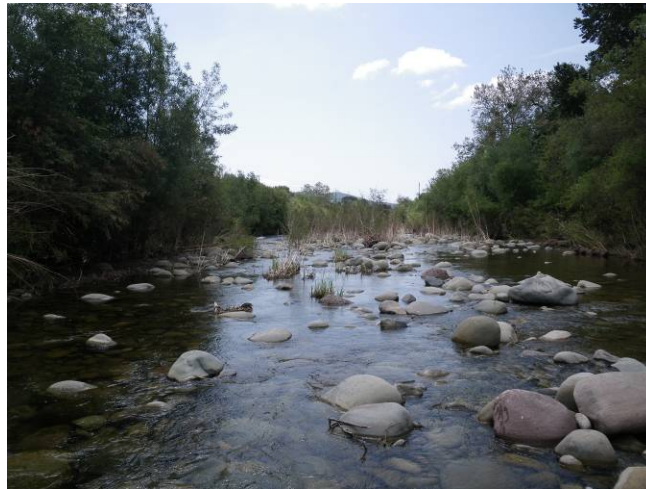
Appendix 15a. Photos of Site 2 impediment on 13 April 2011 during 64 cfs, as measured at Foster Park USGS gage, looking from: (A) upstream, (B) upstream from upstream edge of impediment, and (C) downstream from upstream edge of impediment.

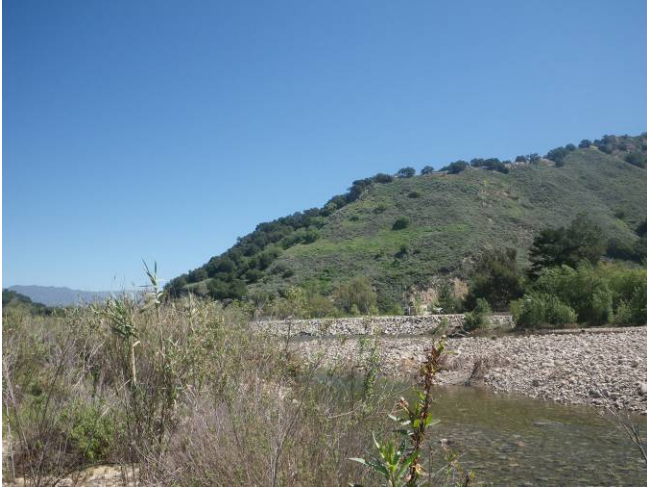
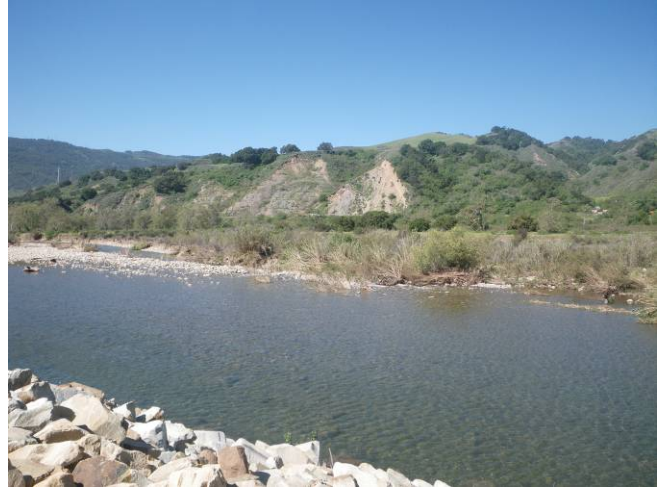
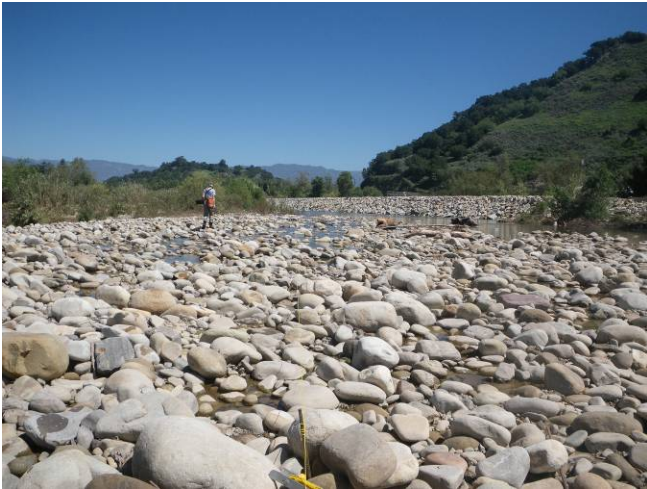
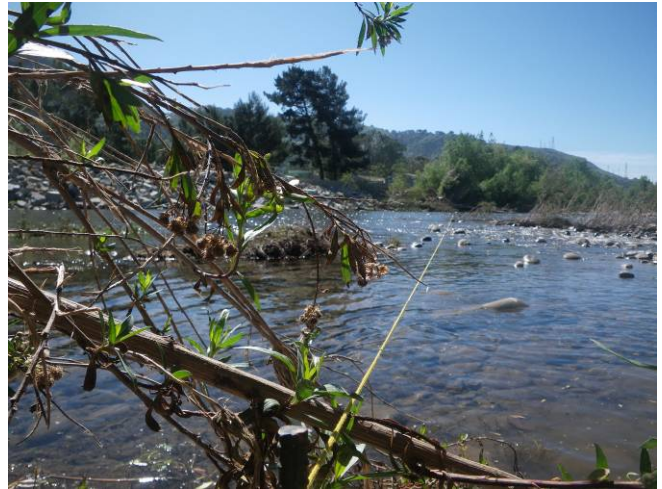
Appendix 15b. Photos of Site 3-2 impediment on 05 April 2011 during 30 cfs discharge release from Robles Fish Facility, looking from: (A) downstream, (B) upstream, (C) right to left bank, and (D) left to right bank.

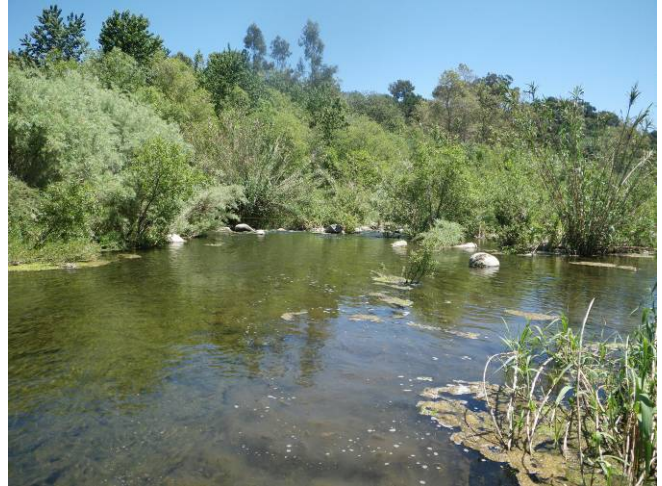
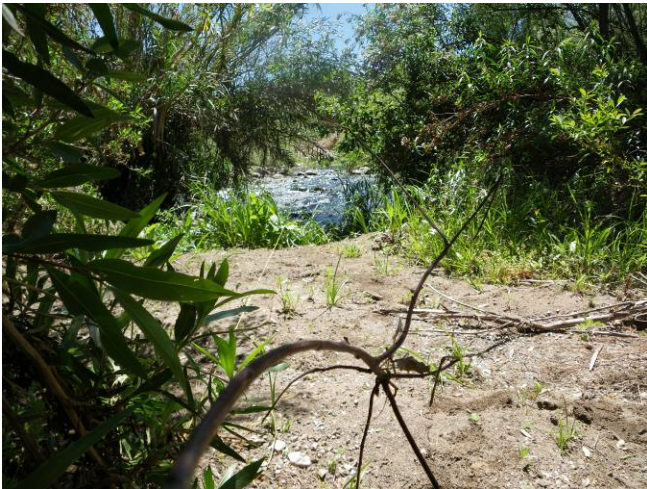
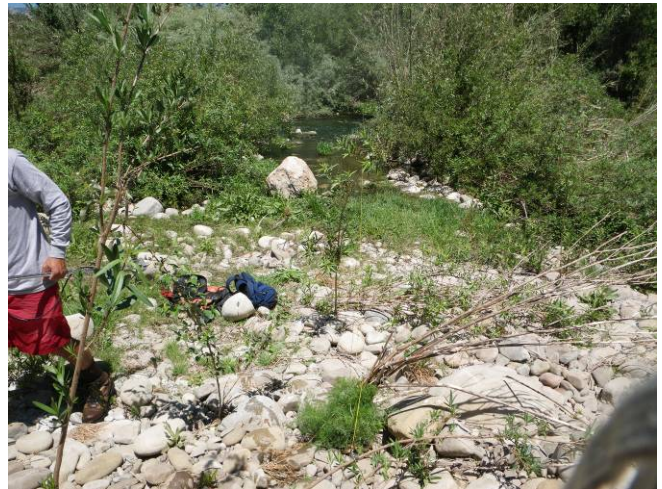
Appendix 15c. Photos of Site 4 impediment on 26 April 2011 during 31 cfs discharge release from Robles Fish Facility, looking from: (A) downstream, (B) upstream, (C) right to left bank, and (D) left to right bank.

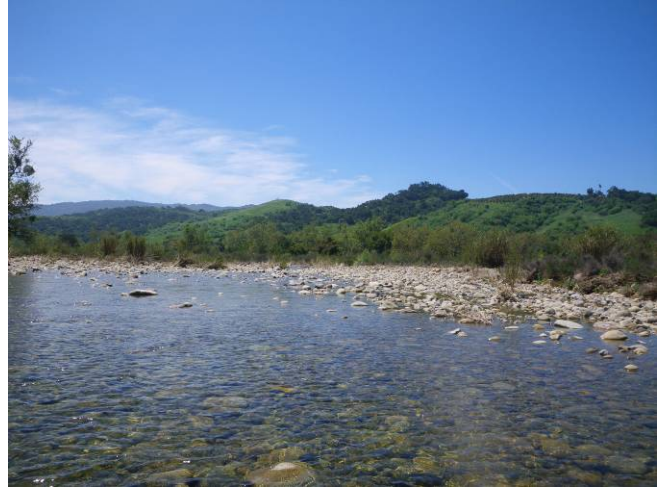
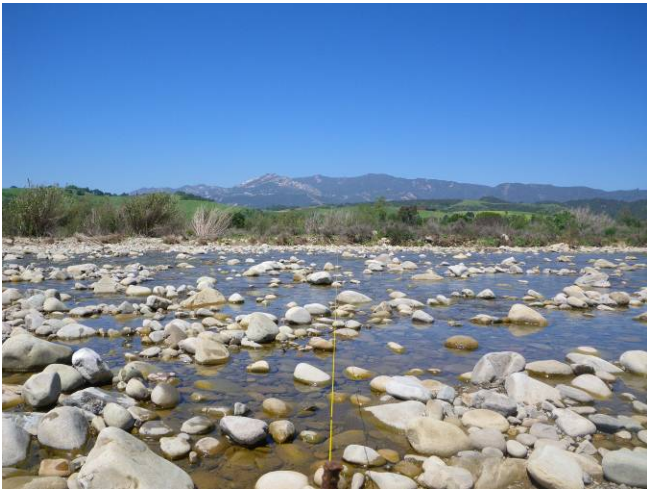
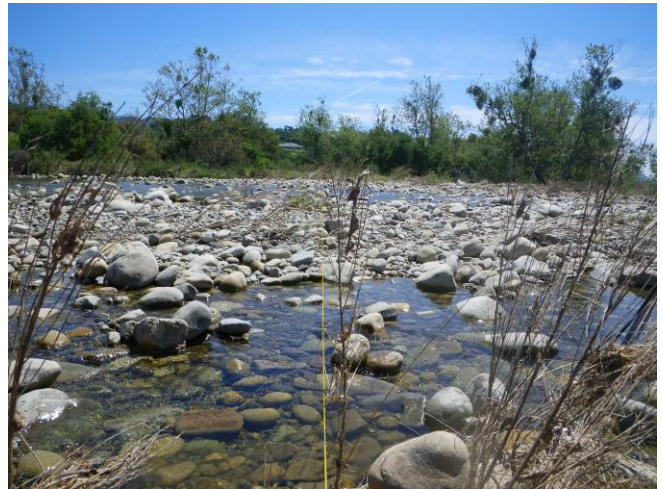
Appendix 15d. Photos of Site 5-2 impediment on 05 April 2011 during 30 cfs discharge release from Robles Fish Facility, looking from: (A) downstream, (B) upstream, (C) right to left bank, and (D) left to right bank.

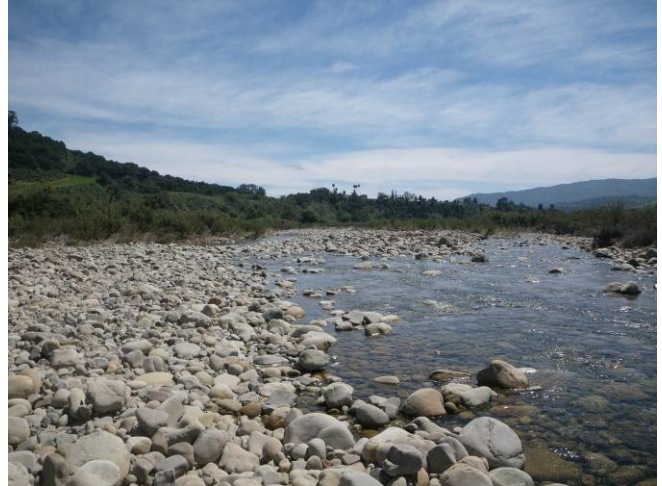
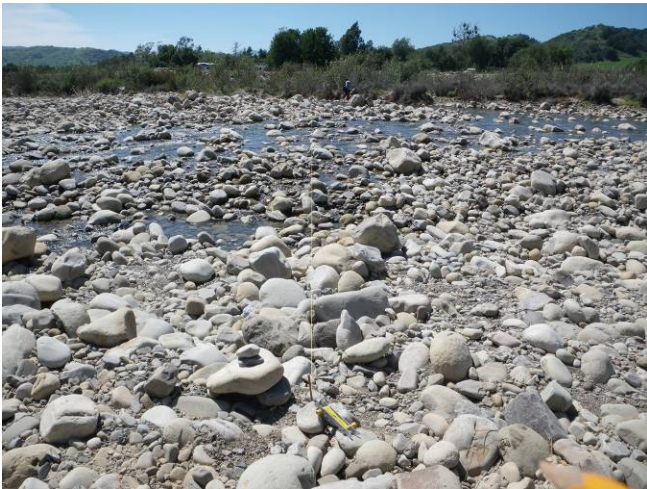
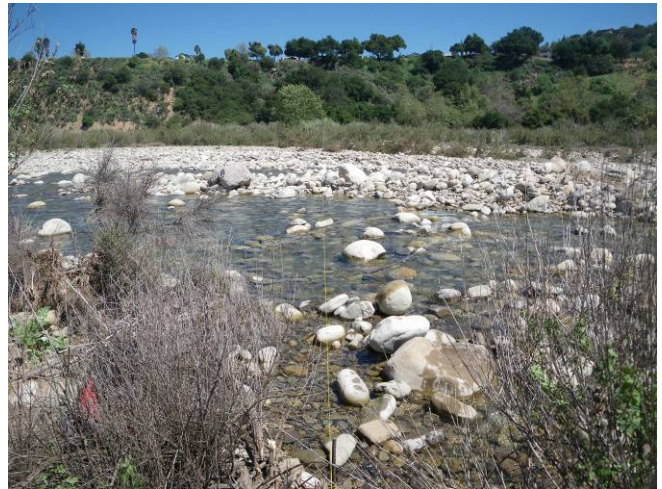
Appendix 15e. Photos of Site 6-2 impediment on 05 April 2011 during 30 cfs discharge release from Robles Fish Facility, looking from: (A) downstream, (B) upstream, (C) right to left bank, and (D) left to right bank.

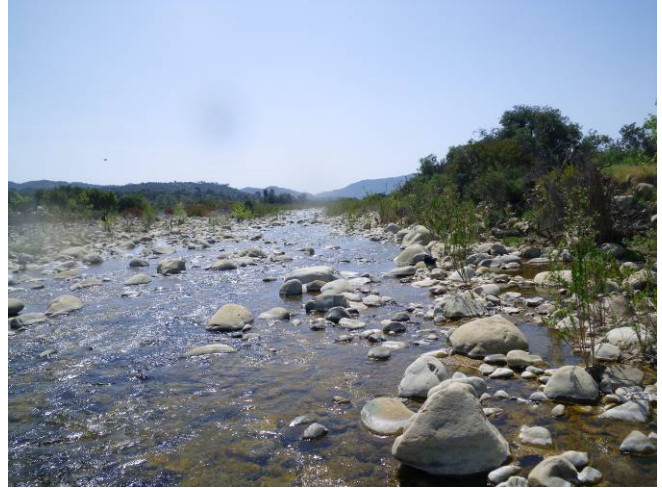
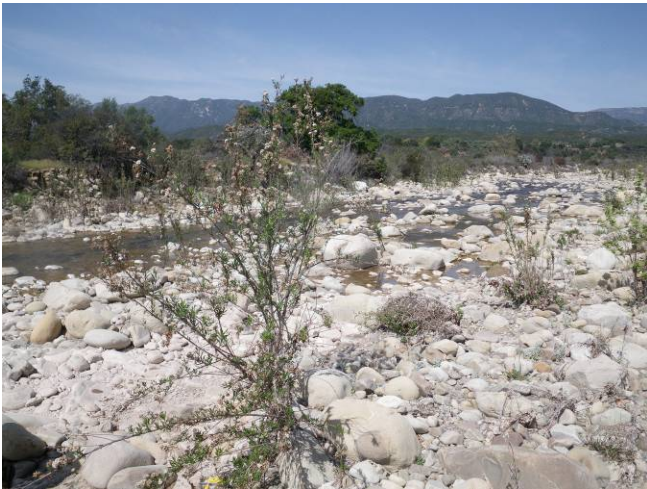
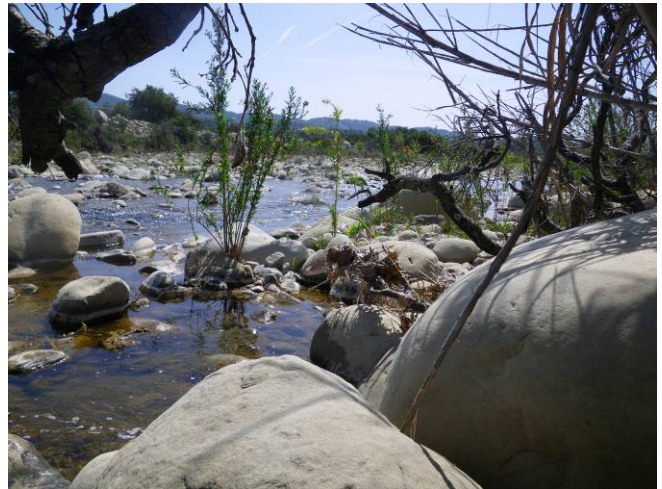
Appendix 15f. Photos of Site 7 impediment on 26 April 2011 during 31 cfs discharge release from Robles Fish Facility, looking from: (A) downstream, (B) upstream, (C) right to left bank, and (D) left to right bank.

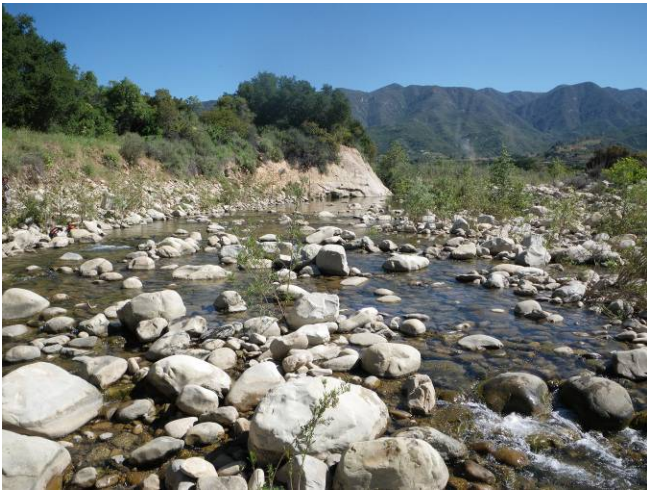
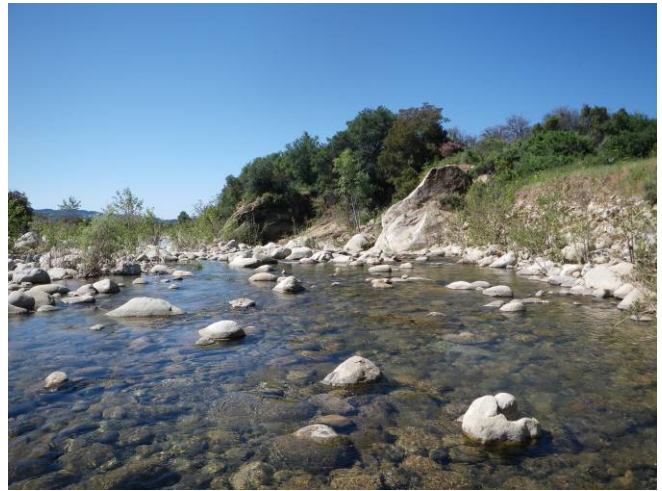
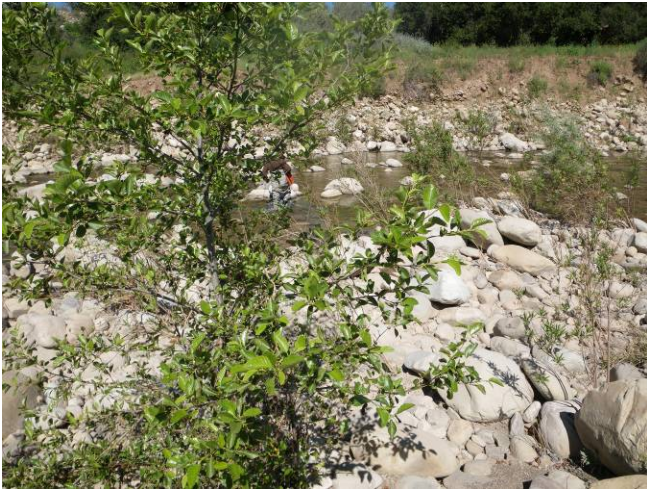
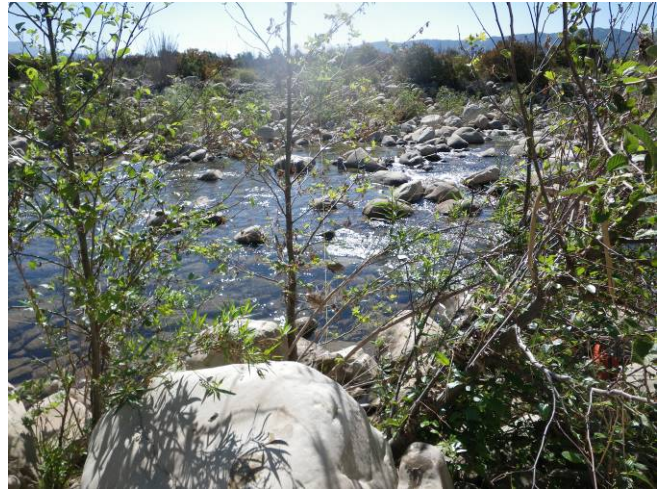
Appendix 15g. Photos of Site 8 impediment on 26 April 2011 during 31 cfs discharge release from Robles Fish Facility, looking from: (A) downstream, (B) upstream, (C) right to left bank, and (D) left to right bank.

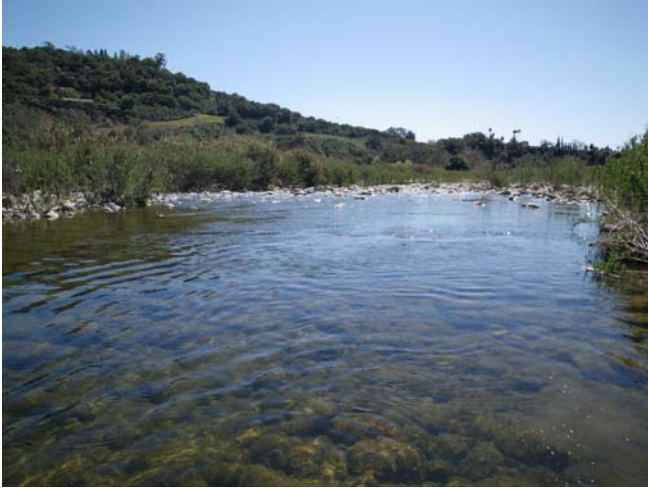
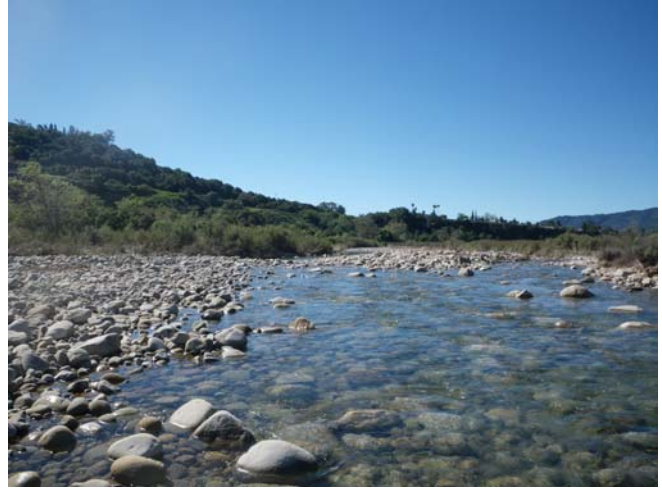
Appendix 15h. Photos of Site 6 impediment Site 6 looking downstream on 09 March 2011 (A) during 36 cfs discharge release from Robles Fish Facility and looking downstream from similar location on 01 April 2011 (B) during 39 cfs.
