2020 Robles Fish Passage Facility Progress Report

Casitas Municipal Water District
1055 Ventura Avenue
Oak View, California 93022

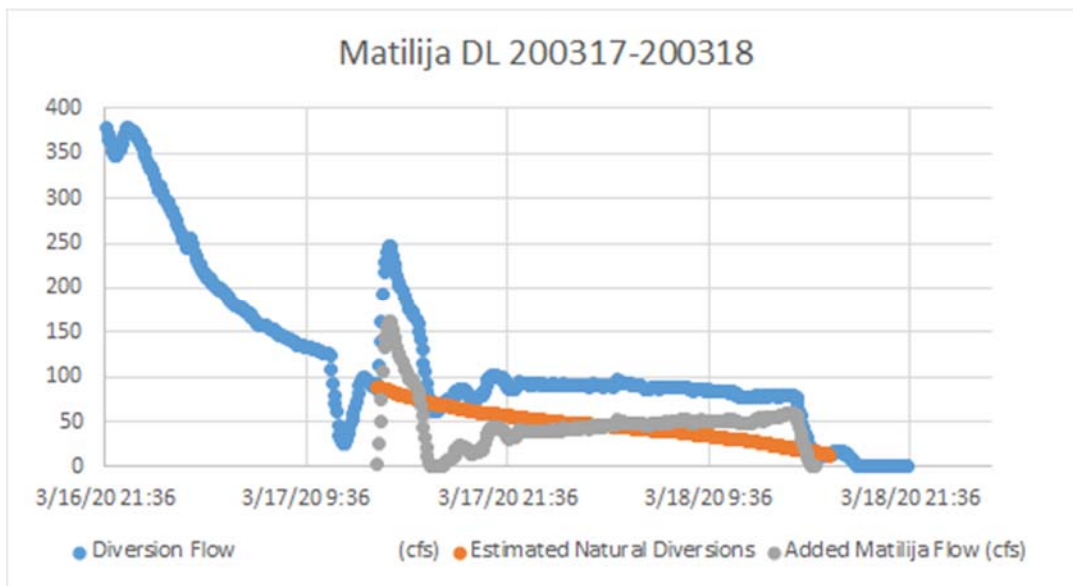
The download for 2020 was determined by subtracting the estimated natural diversions (orange line) from the actual diversions (blue line) to estimate the additional diversions for the period of the download (gray line).

Critical Drought Protection Measures—One CDDM download was completed during 2020, after the 17 March storm event, and was estimated at 102 af (see figure below). The estimated 102 af was determined by accounting for the expected natural recession rate during the period of the download and subtracting it from the actual diversions. The of 102 af download for 2020 is essentially the same as the 2019 download of 101 af. These download estimates support a conclusion that the Matilija Reservoir volume is less than previously thought.

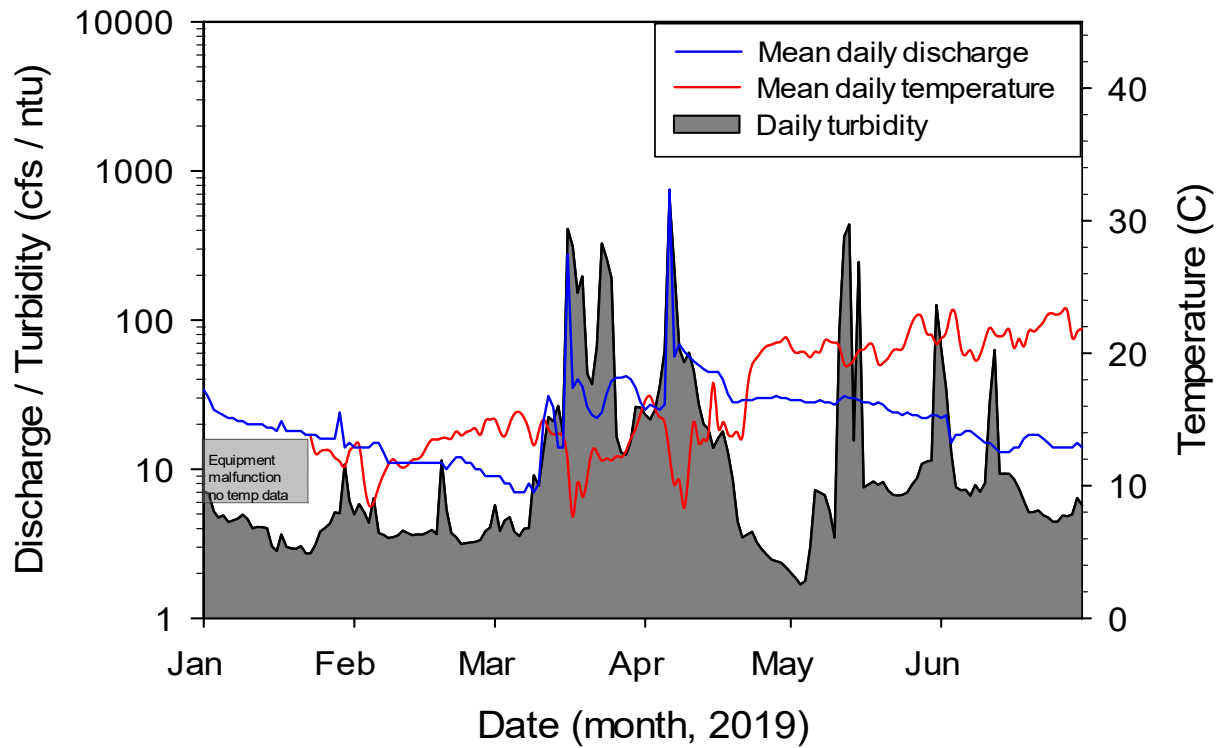
Appendix 21. Mean daily discharge, water temperature, and turbidity at the Robles Fish Facility during the 2020 fish passage season.

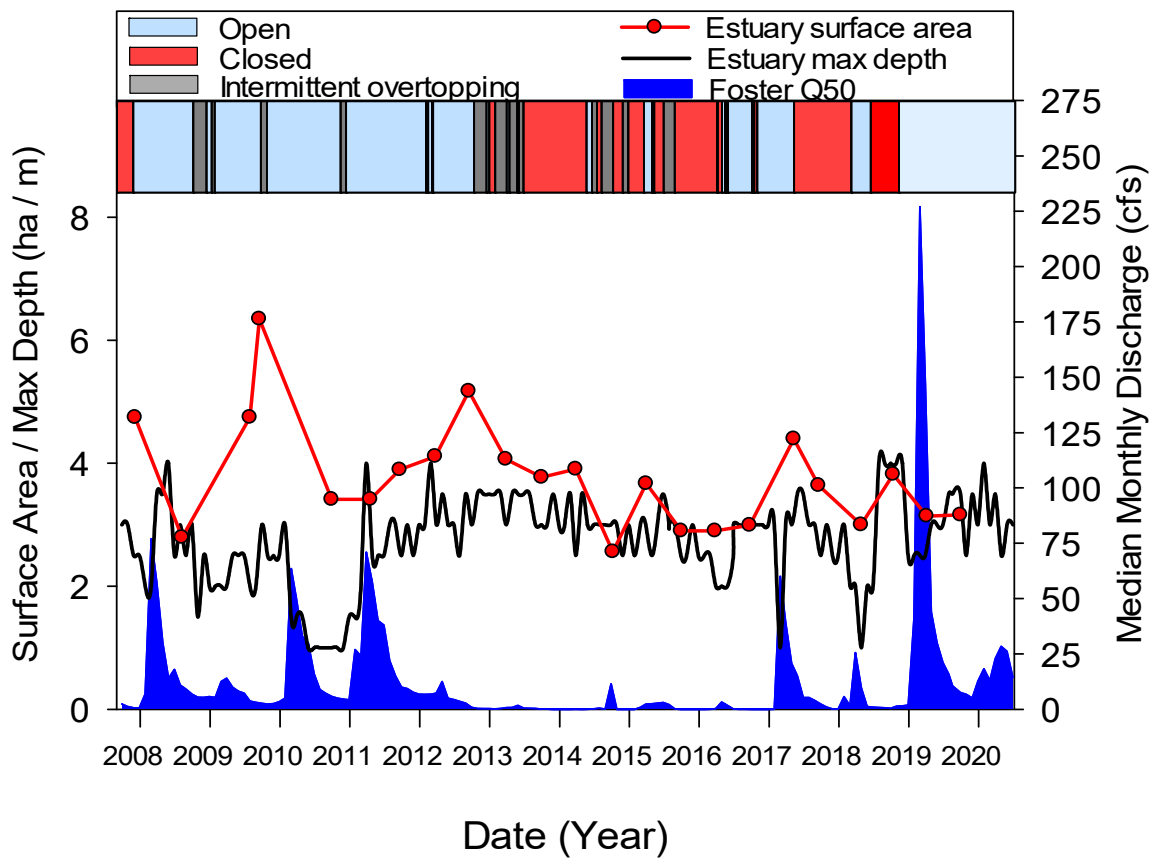
Appendix 31. Ventura River estuary/lagoon water depth, surface area, sandbar status, and discharge at Foster Park from 2008 to 2020.
