2019 Robles Fish Passage Facility Progress Report

Casitas Municipal Water District 1055 Ventura Avenue Oak View, California 93022

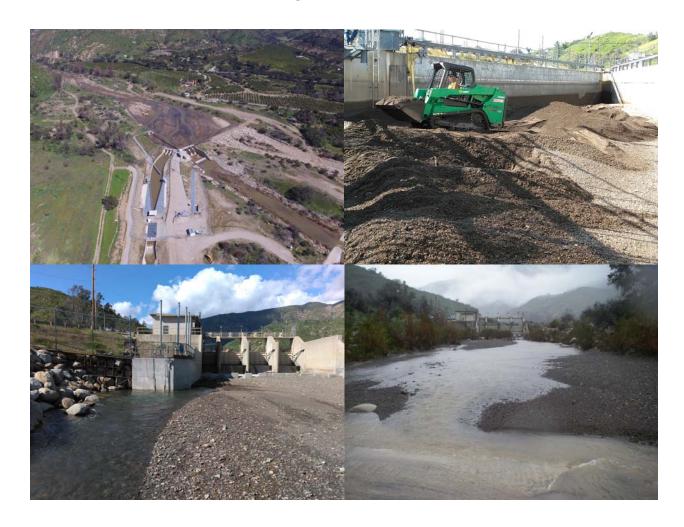
Storms during 2019 transported extensive Thomas Fire sediment downstream from the upper Ventura River basin. Sediment was transported into the Robles forebay until full, which then moved into the Robles Fish Passage Facility. Top left photo is aerial of Robles Facility showing sediment accumulation in forebay, top right is sediment removal process from screenbay, bottom left is sediment that filled in entrance pool (channel on left bank remained open because of fish ladder flows), and bottom right is showing sediment-filled channel upstream of the measurement weir.

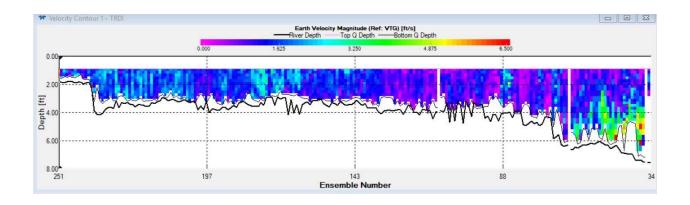
collect at least some initial data and practice deployment methods. Below is a screen shot from ADCP software for one of the velocity profile transects. Even at a fish ladder flow of 50 cfs, water velocities were higher near the fish ladder exit (profile is looking downstream and higher velocities from fish ladder are on the right side). A full report of the Water Velocity and Depth Validation Evaluation will be completed once data collection has been completed for all tasks the BC determines necessary.

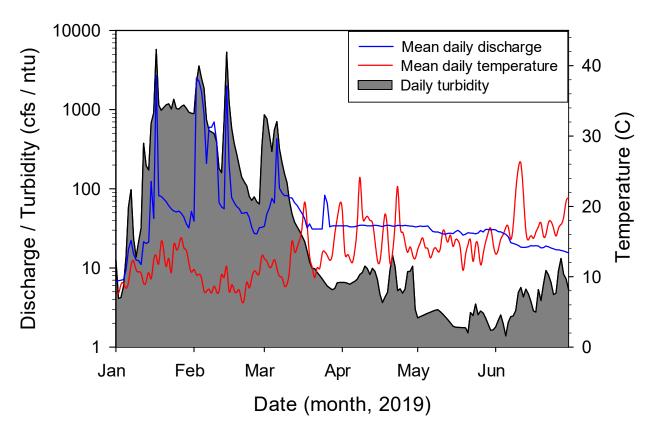
Appendix 21. Mean daily discharge, water temperature, and turbidity at the Robles Fish Facility during the 2019 fish passage season.

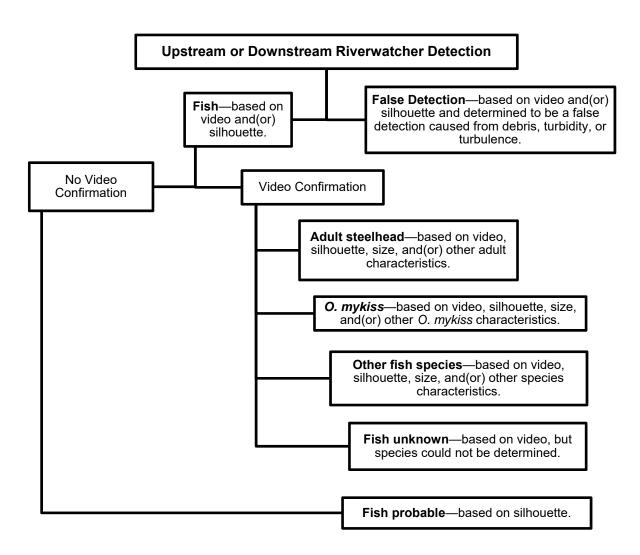
Appendix 22. Riverwatcher detection classification flow chart that outlines the pathways for upstream and downstream detections.

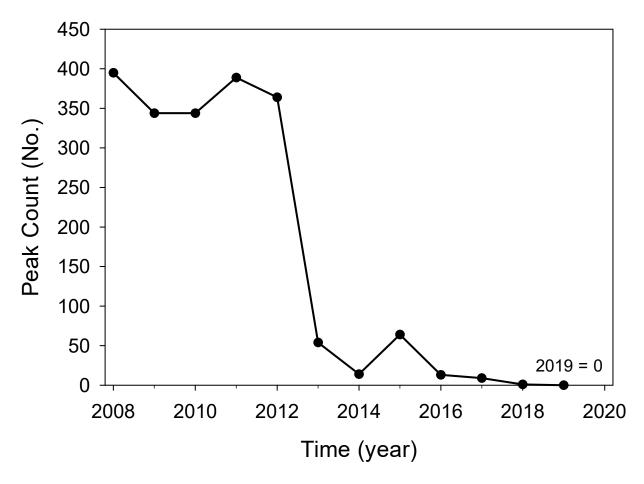
Appendix 25. Peak snorkel counts of *O. mykiss* during the period 2008-2019 at survey index sites in the Ventura Basin.

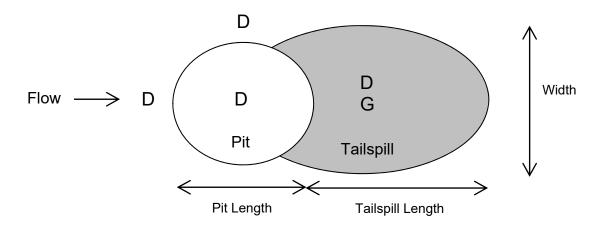
Appendix 27. Diagram of *O. mykiss* redds measurements. (D) = locations of depth measurements and (G) = location of gravel substrate sampling.

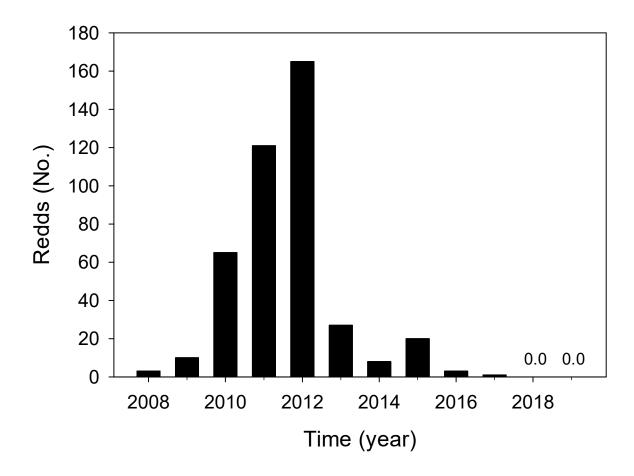
Appendix 28. Total number of *O. mykiss* redds counted at index spawning sites from 2008 through 2019 spawning years.

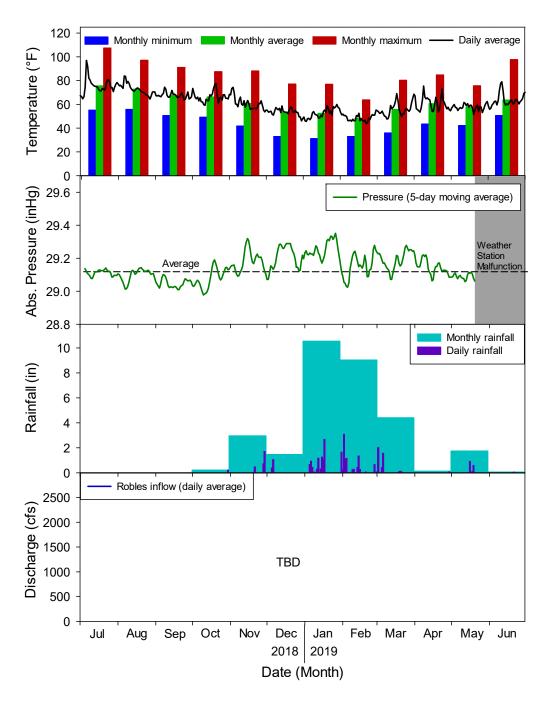
Appendix 30. Summary of weather and discharge data from the Robles Fish Facility for the reporting period.

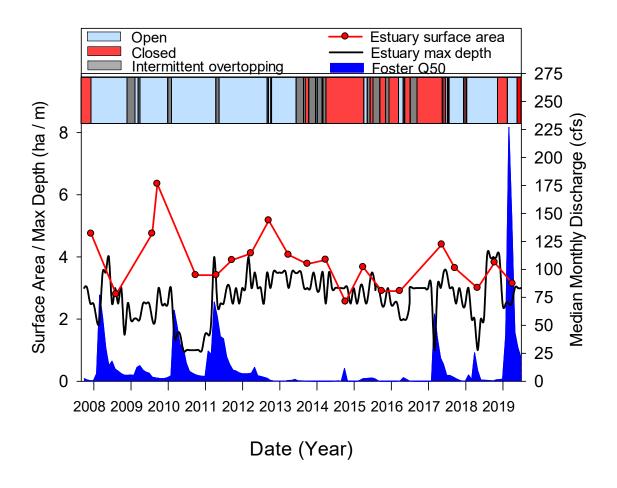
Appendix 31. Ventura River estuary/lagoon water depth, surface area, sandbar status, and discharge at Foster Park from 2008 to 2019.

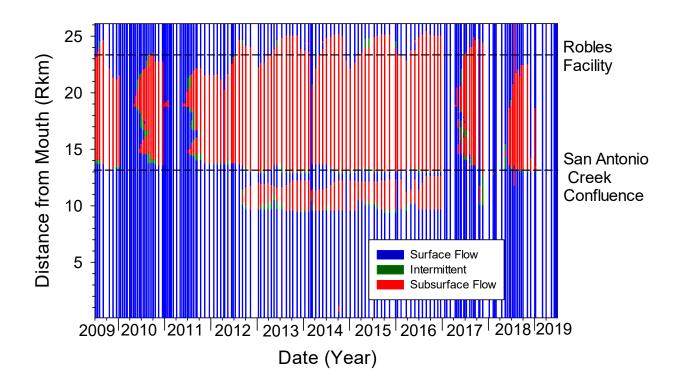
Appendix 32. Ventura River channel surface flow monitoring from 2008 to 2019.

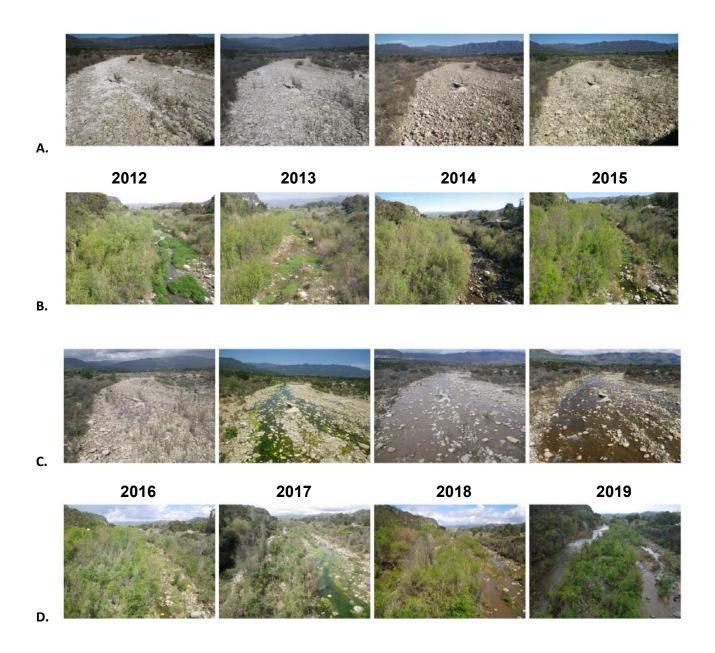
Appendix 34. Multiple year photo comparison of ephemeral and perennial reaches of the Ventura River. Photo series row A and row C are looking upstream from Hwy 150 bridge. Photo series row B and row D are looking upstream from the bridge near the Shell Rd exit off Hwy 33.
